STRUCTURES INSPECTION FIELD REPORT

B.I.N.
2M4

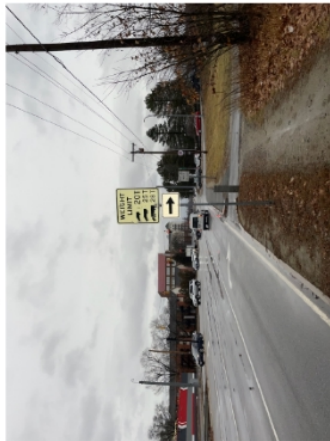
① Advance weight posting sign that reads: "20, 25, and 28 tons."

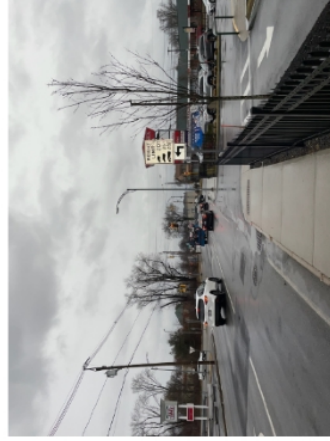
⑥ Advance weight posting sign that reads: "20, 25, and 28 tons."

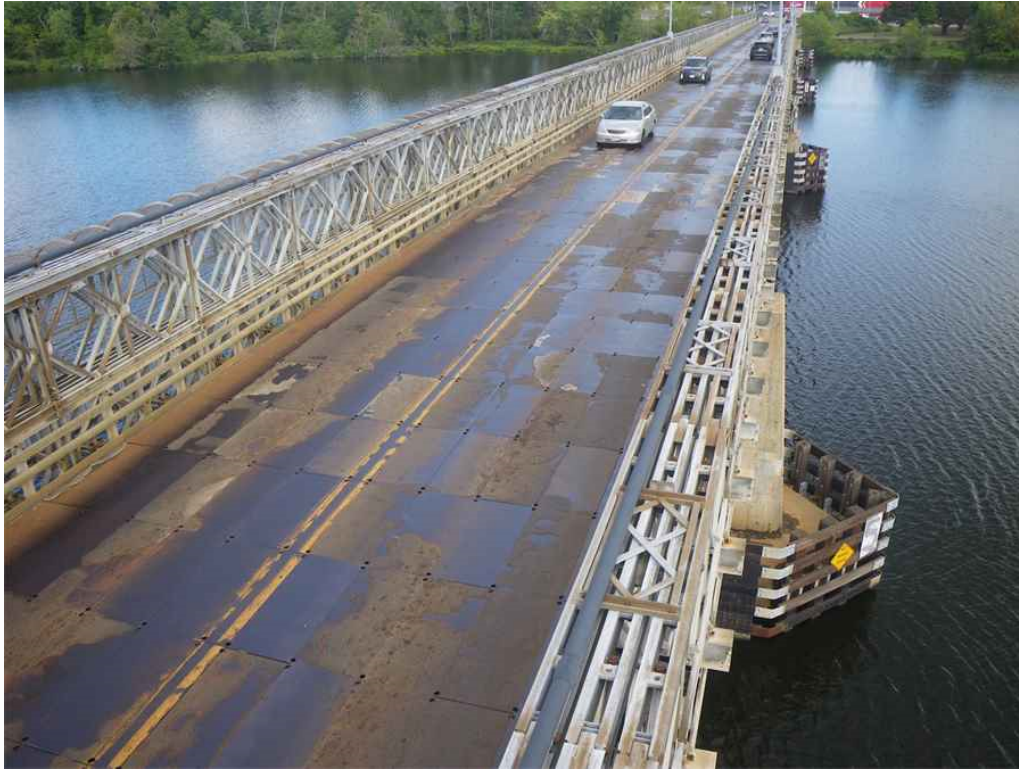
Photo 1: Span 4, Roadway Deck Panels, Looking North - General view of areas of missing epoxy aggregate wearing surface exposing surfaces of steel panels below.

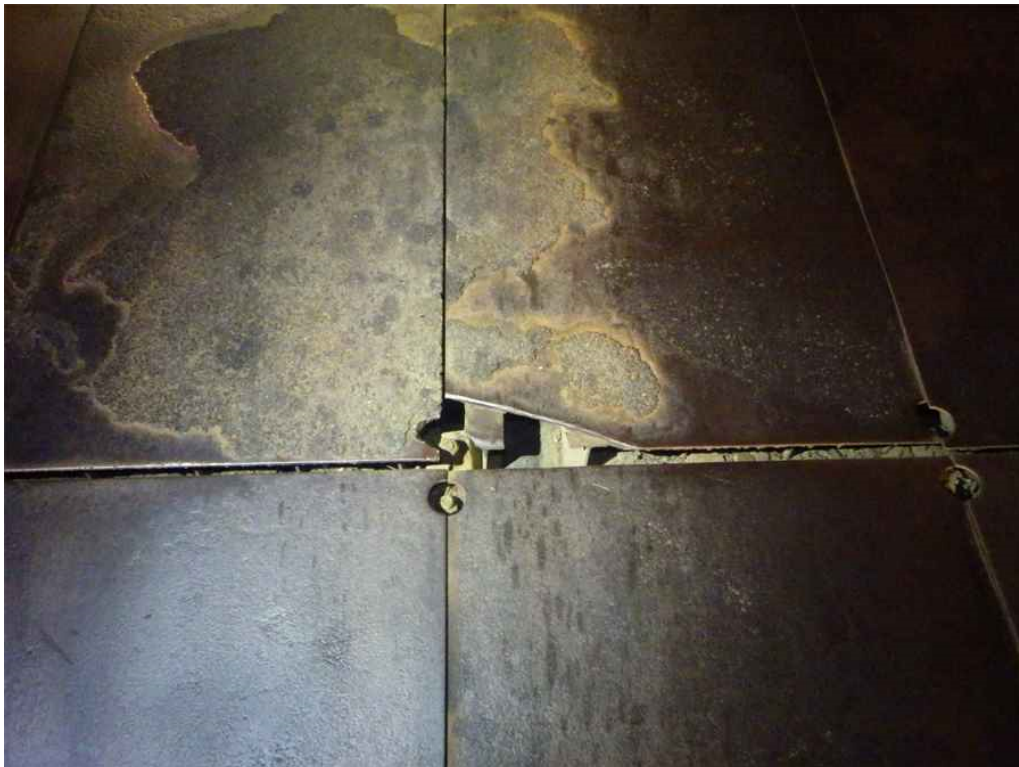
Photo 2: Span 8, Roadway Deck Panel North of T5, 3rd Panel from East Curb, Looking North - Areas of missing epoxy aggregate wearing surface exposing surface of steel panel below. Note fracture at corner.

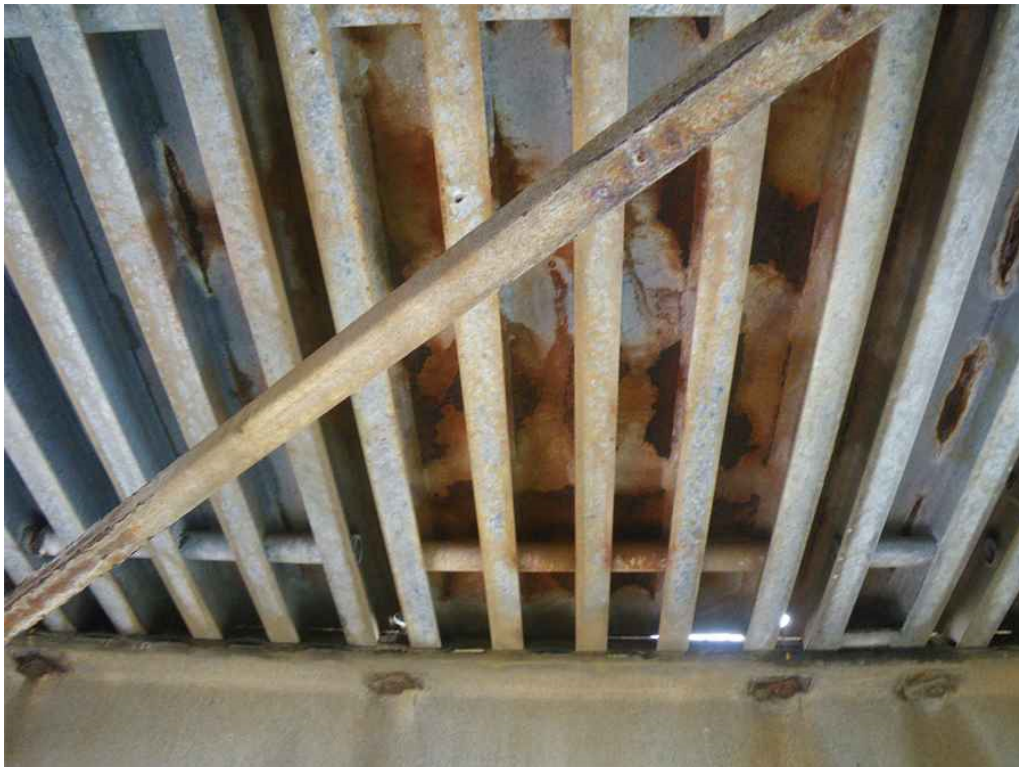
Photo 4: Span 4, Roadway Deck Panel between T4 and T5, 5th Panel from East Curb, Looking South - Failed galvanization and heavy surface rust on underside.

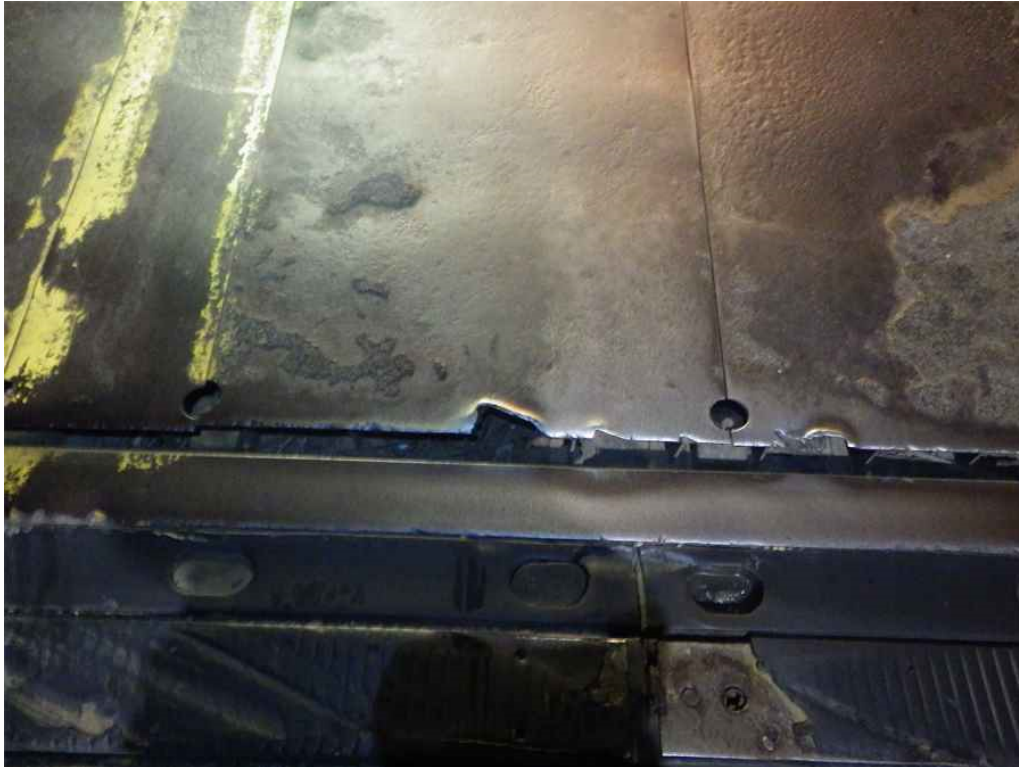
Photo 5: Span 2, Roadway Deck Panel South of T12, 11th Panel from East Curb, Looking North - 3" long by 4" wide fracture/100% section loss.

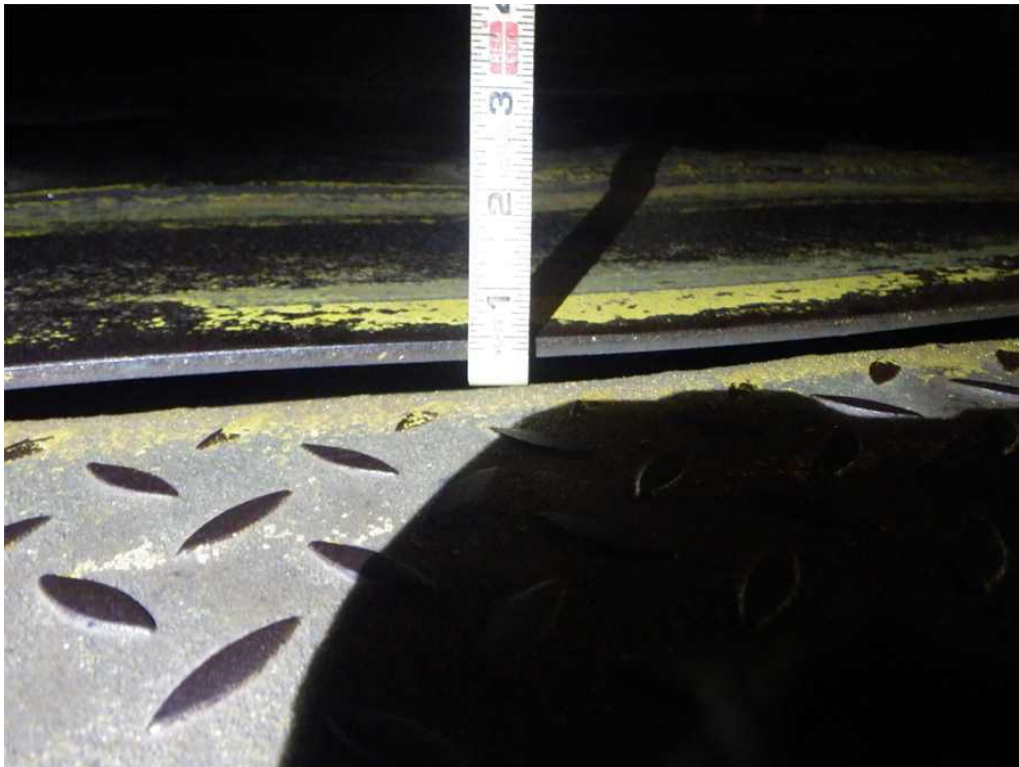
Photo 6: Span 4, Roadway Deck Panel between T4 and T5, 6th Panel (Middle Panel) from East Curb, Looking West - Panel is 1/2" higher than adjacent panel to east.

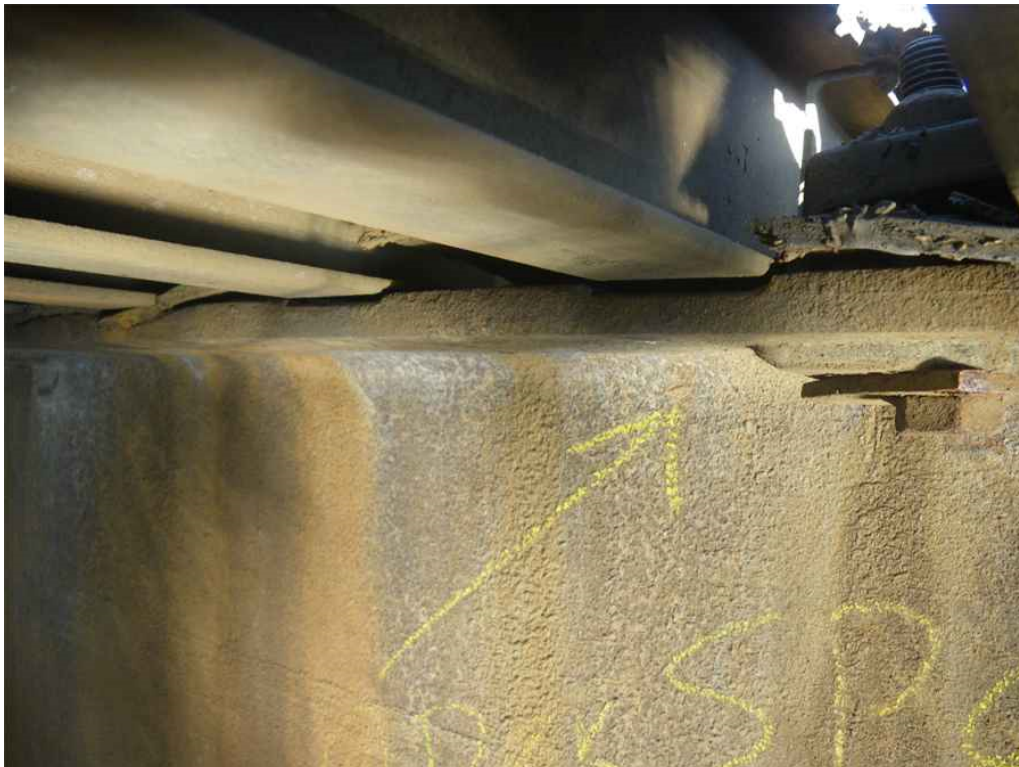
Photo 8: Span 6, Transom T12 Top Flange below 10th Roadway Deck Panel from East Curb, South Face of T12, Looking North - Four purlins have mutual wear with transom top flange, caused by loose panel above.

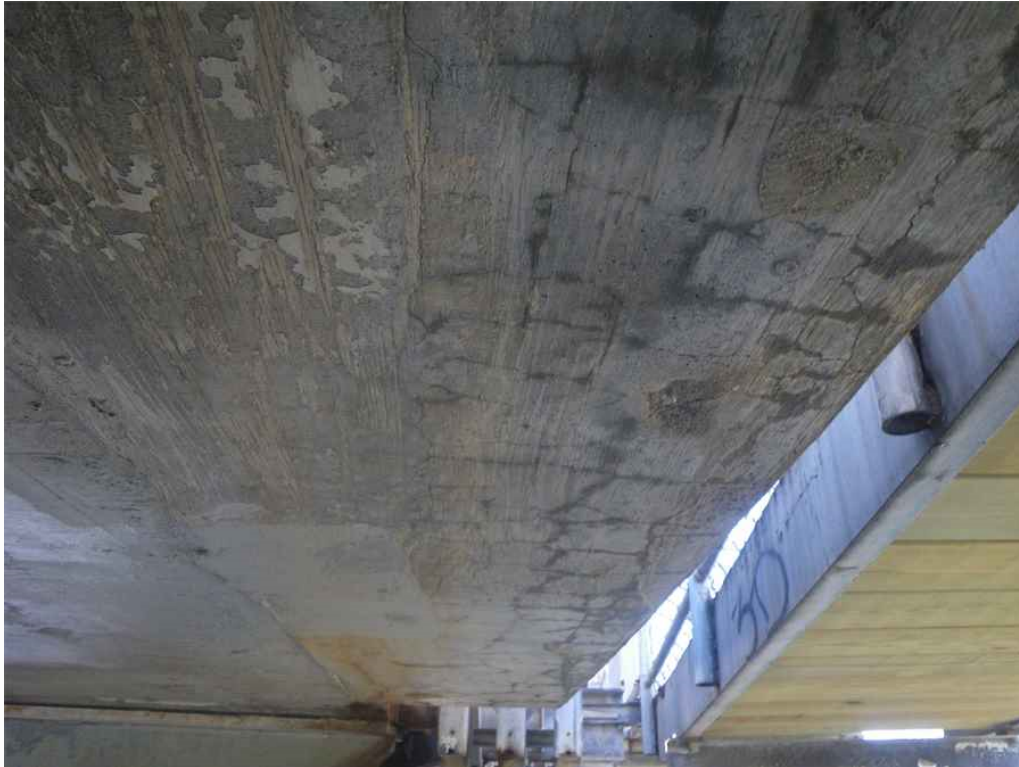
Photo 9: Span 9, Underside of Deck, At West Fascia, Looking South - Hairline map cracking with moisture throughout edge of deck. Note timber shielding in place below concrete sidewalk.

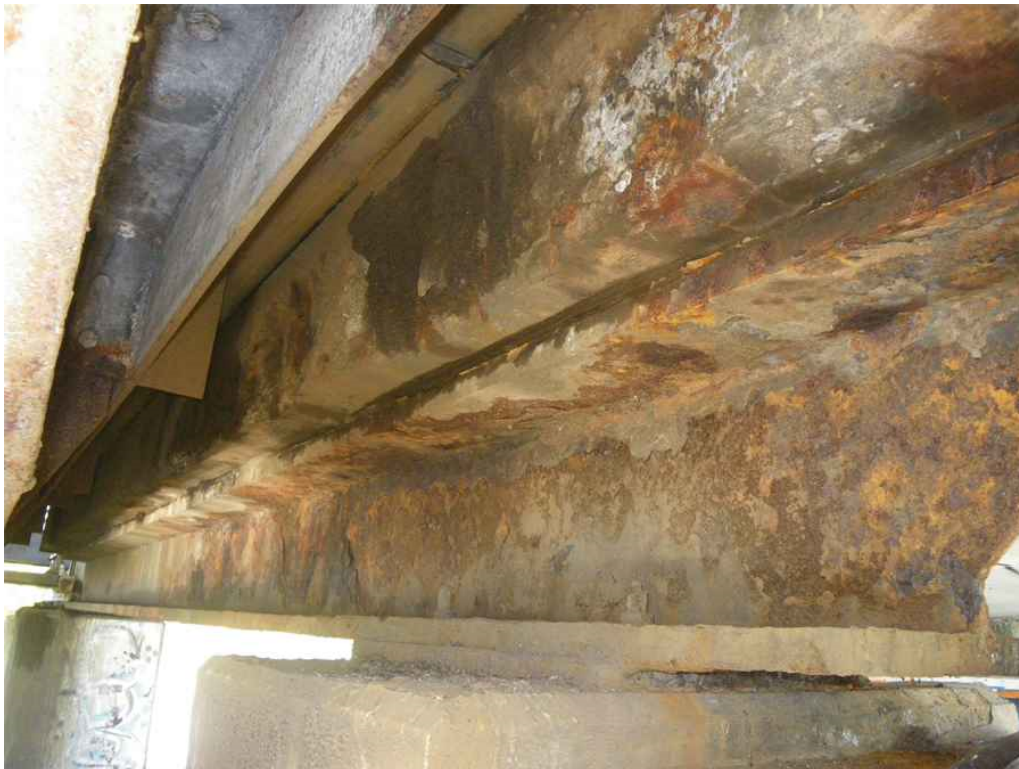
Photo 10: Span 9, at Pier 9, South End Conc Deck, and South Support Floorbeam, South Face, Looking Northwest - Spall with exposed reinforcing. Note floorbeam w/ section loss & pitting along full height.

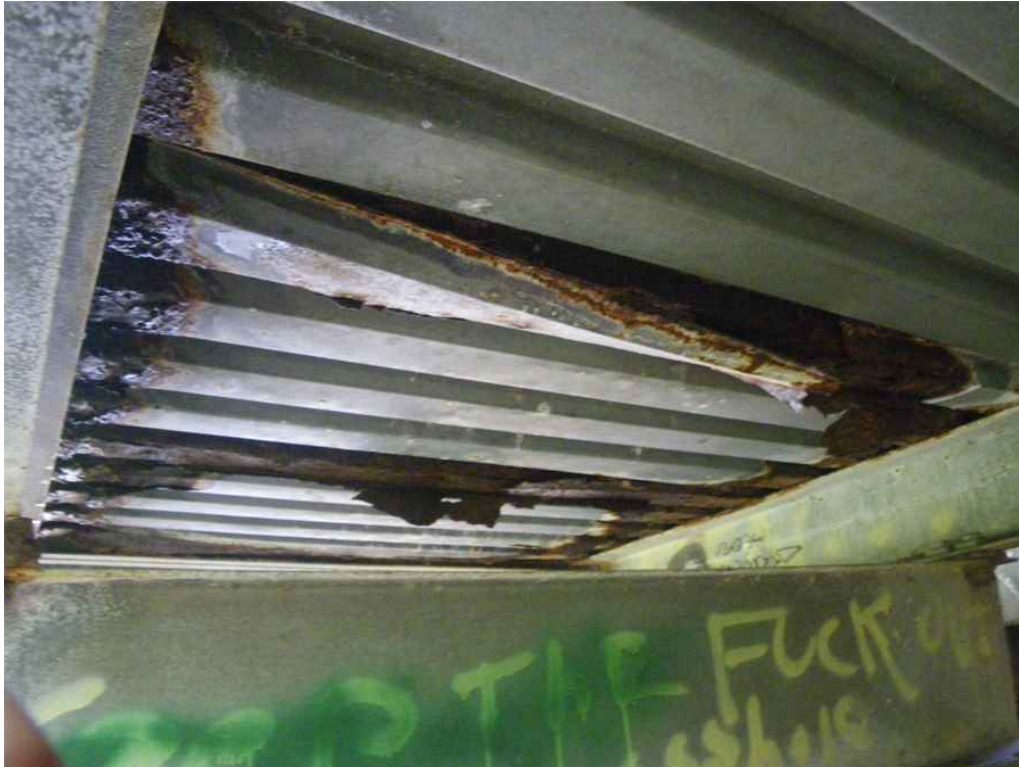
Photo 11: South Approach, SIP Forms under Sidewalk, near South Abutment, Looking Northeast - Areas of heavy rust and corrosion holes along SIP joints and edges.

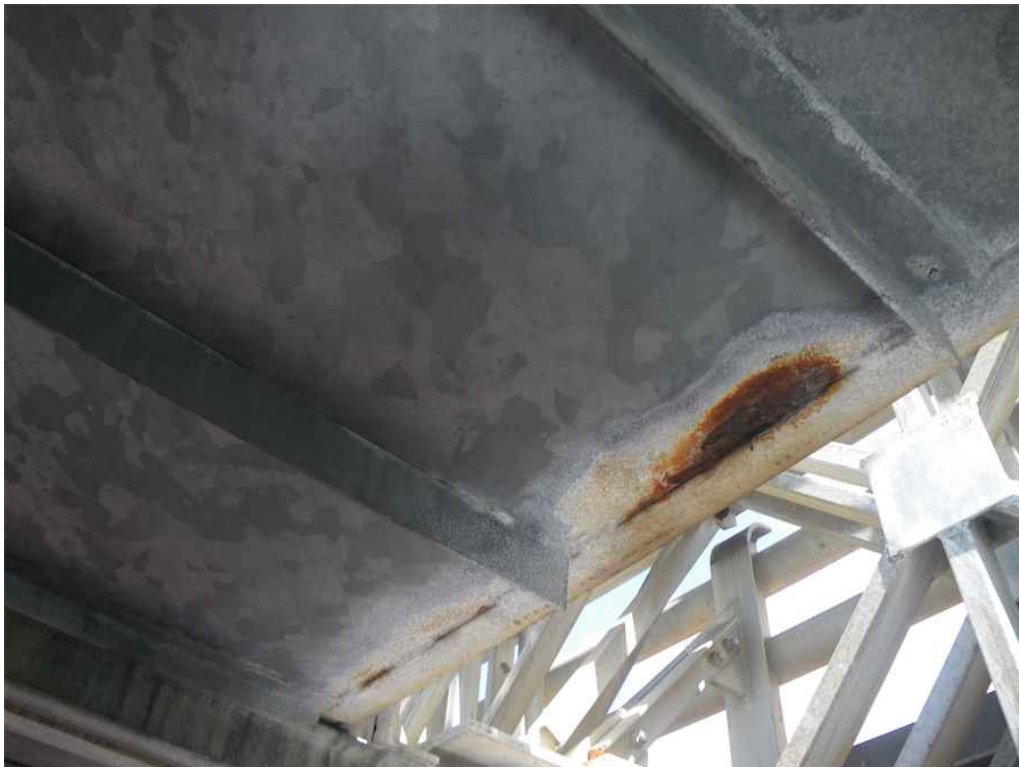
Photo 12: Span 5, Underside Sidewalk, Between T8-T9, Looking East - Moderate surface rust on underside of steel tread plate at edge.

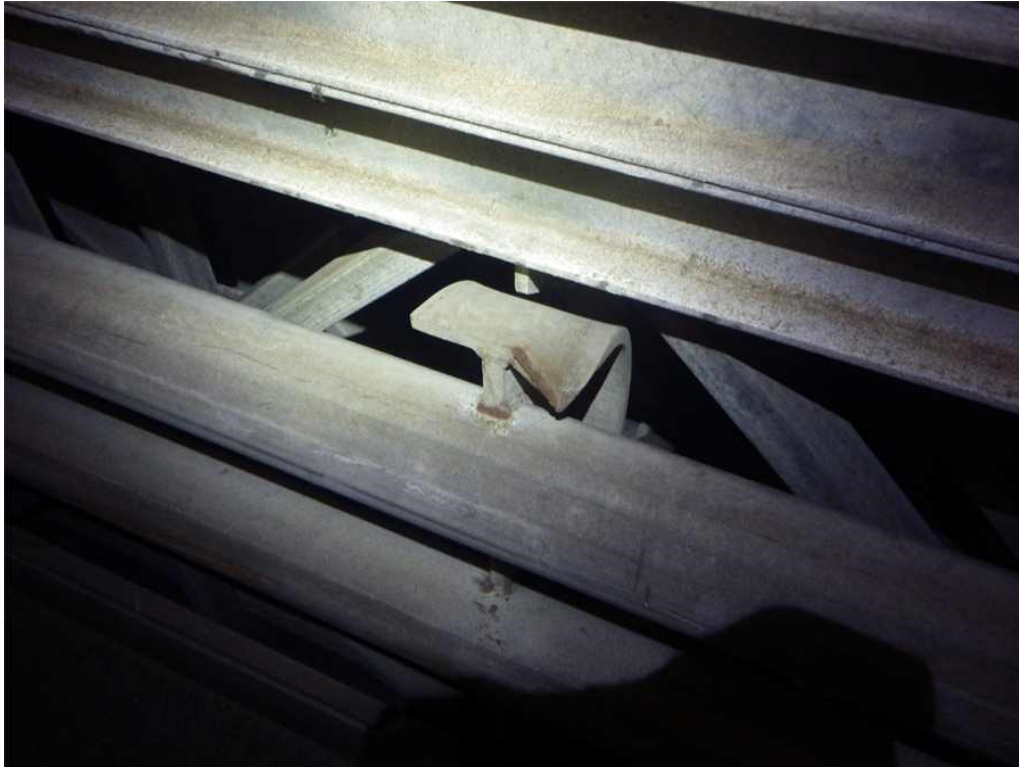
Photo 13: Span 8, West Rail Post at T9, Looking Southwest - Impact damage to north flange bent downwards.

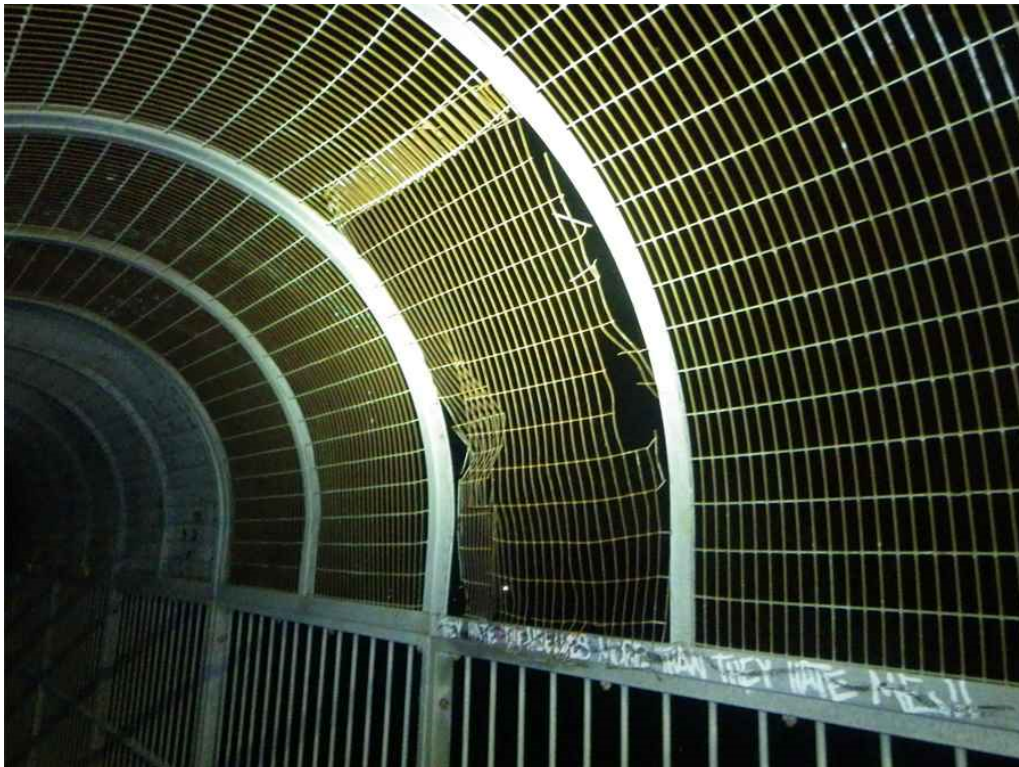
Photo 14: Span 4, Anti-Missile Fence on Sidewalk, between T8-T9, Looking Southwest - West half of previous repair on the anti-missile fence is torn and loose.

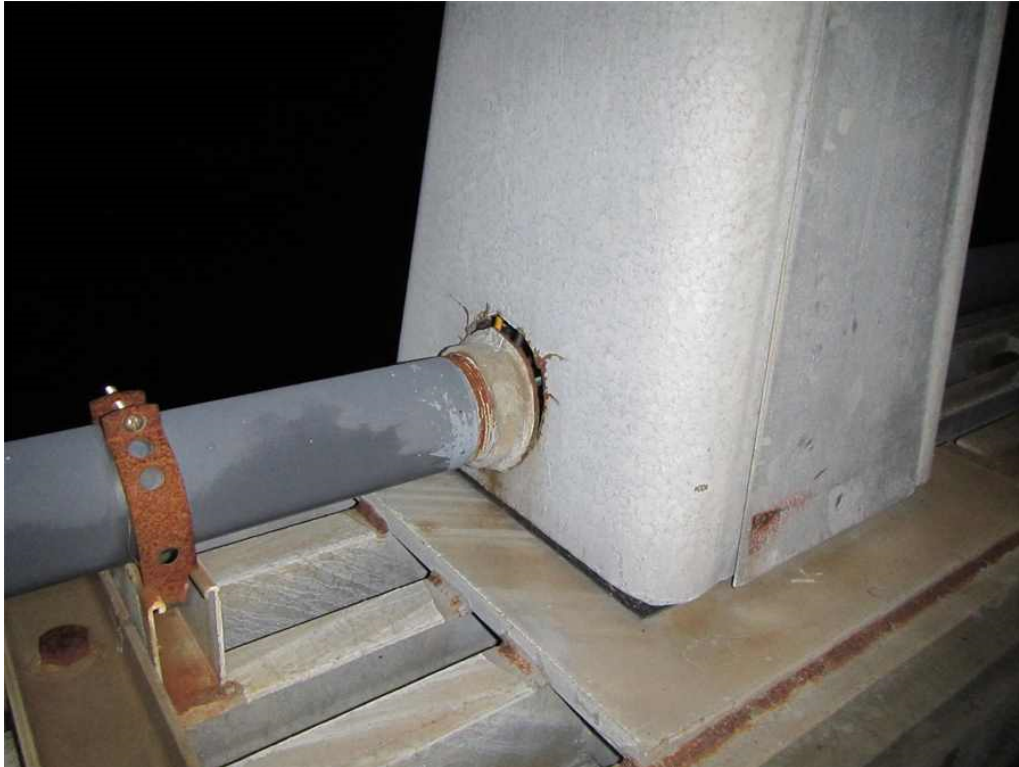
Photo 15: Span 5, Lighting Standard on East Truss, at South Third Point in Span (Pole Marking "20L"), Looking Southeast - 100% cracked weld for conduit connection, w/ cracks emanating east and west.

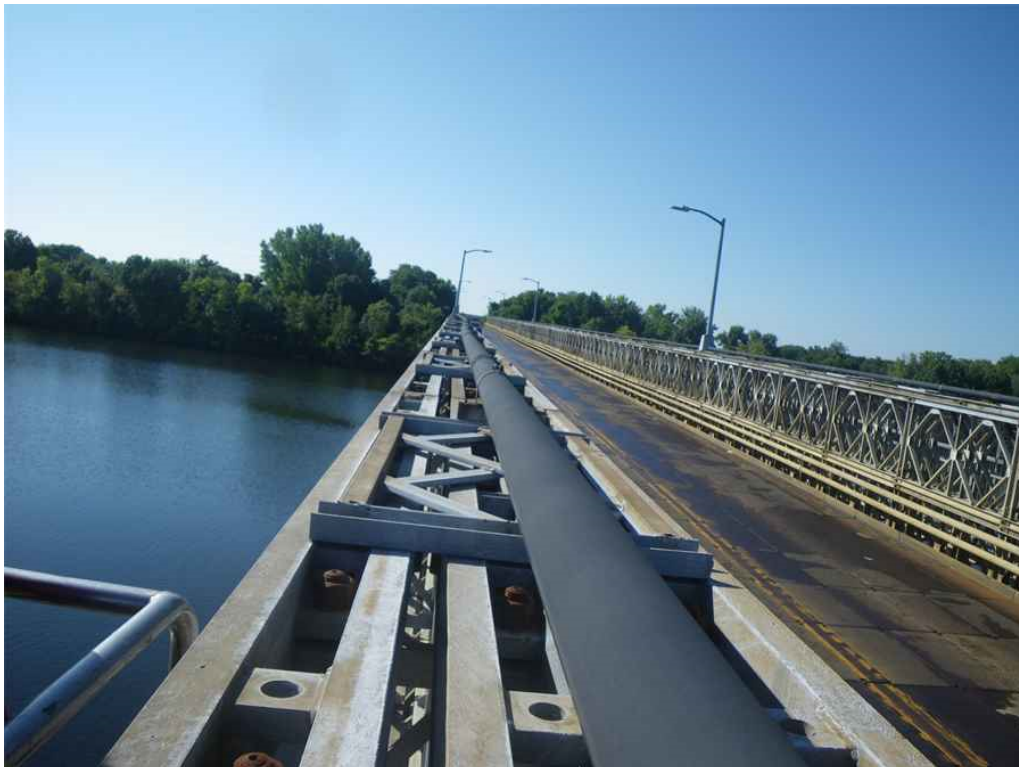
Photo 16: Span 6, Conduit on East Truss, Looking South - Conduit throughout span not seated on the steel brackets, and conduit has shifted.

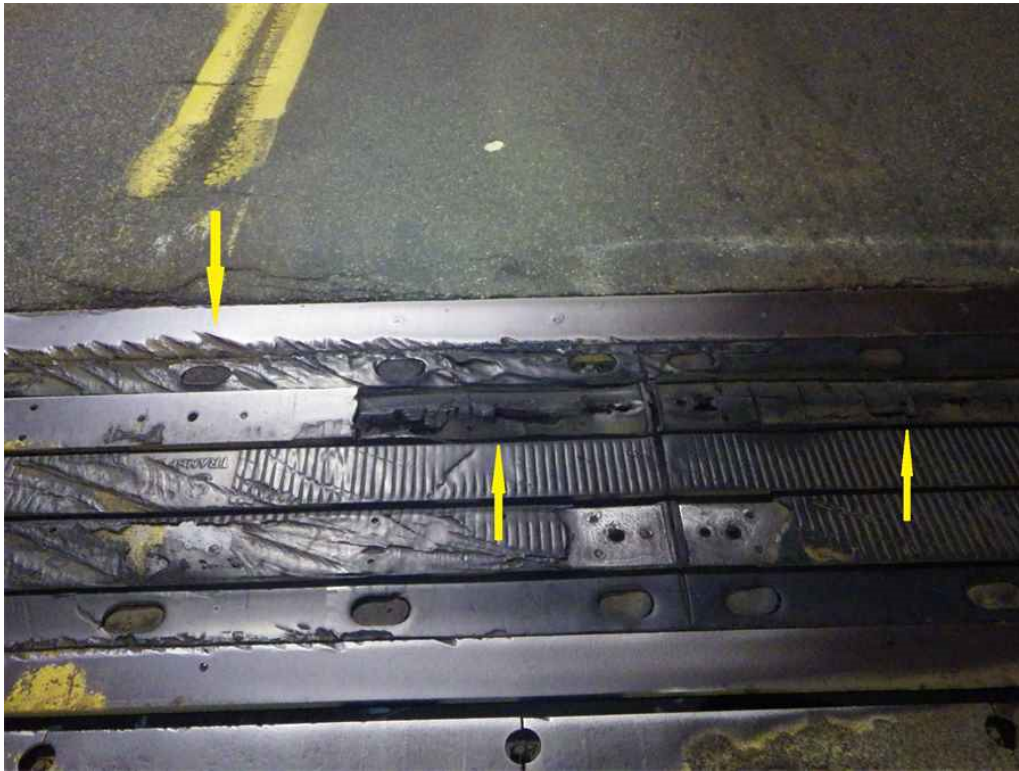
Photo 17: South Abut., Deck Joint, S.B. Lane, Lkg. South - Gouged & worn elastomeric cover exposing the internal plates w/ two missing sections of internal joint plates. Note gouging to joint armor angles.

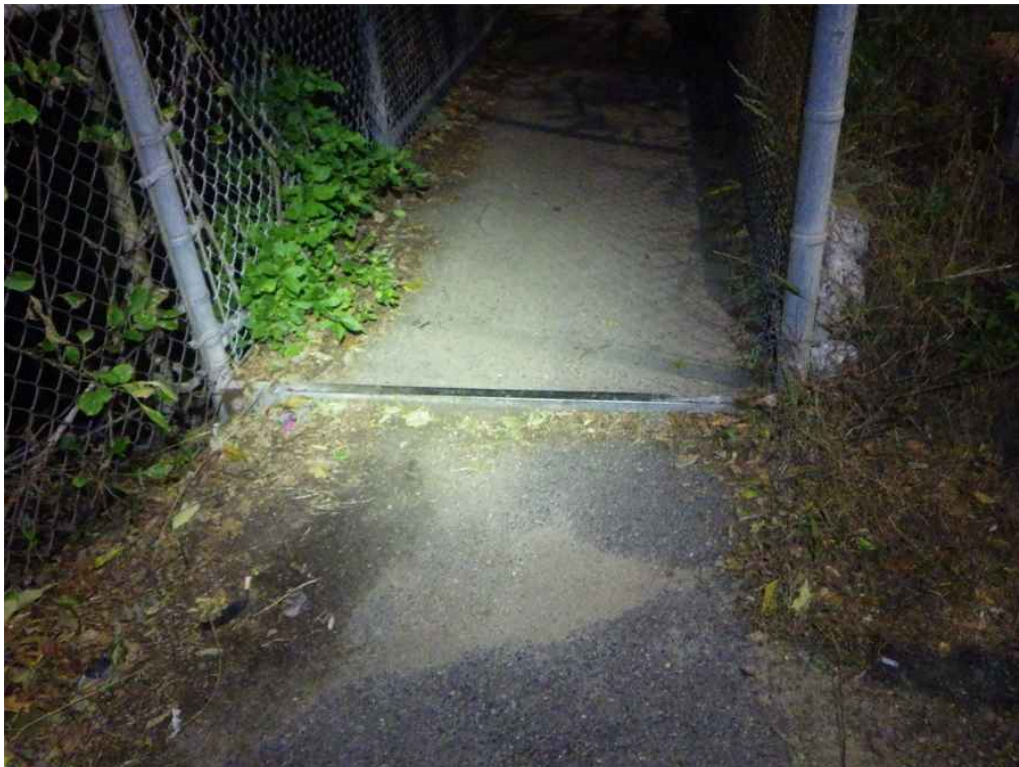
Photo 18: South Approach, Sidewalk, Looking North - Settlement throughout bituminous sidewalk with low points filled with debris.

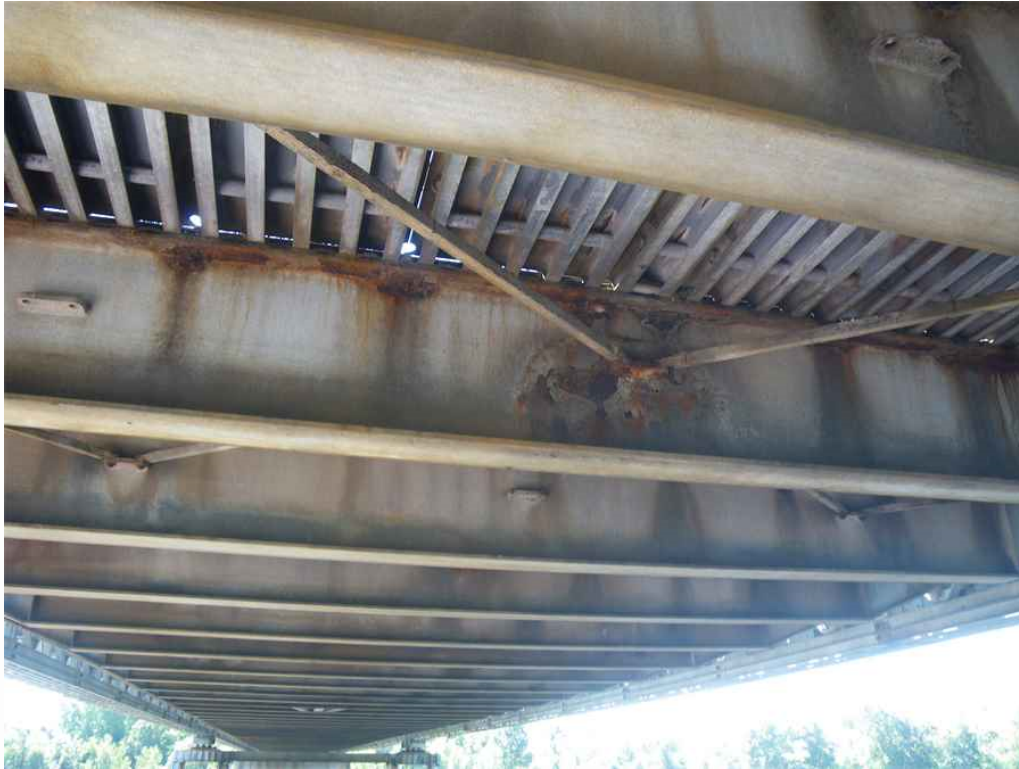
Photo 19: Span 7, Transoms in Northern Third of Span, Looking South - Areas of galvanization loss, and light to moderate surface rust at bottom of web.

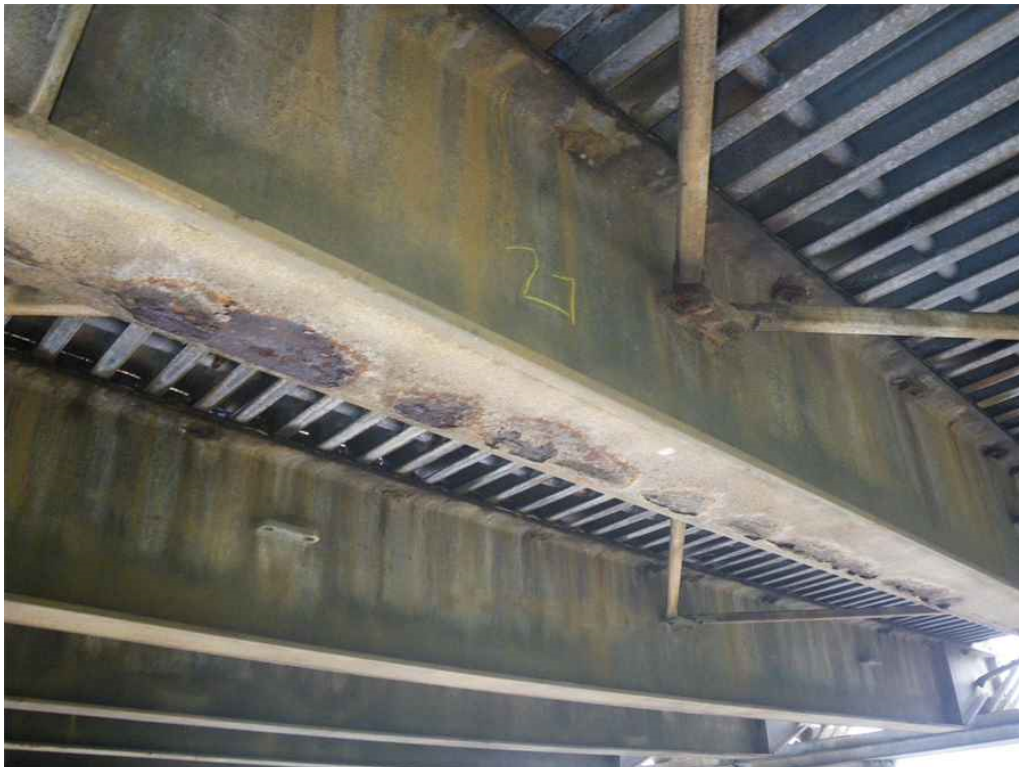
Photo 20: Span 2, Transom T27, Bottom Flange, Looking Northeast - Loss of galvanization and pitting section loss.

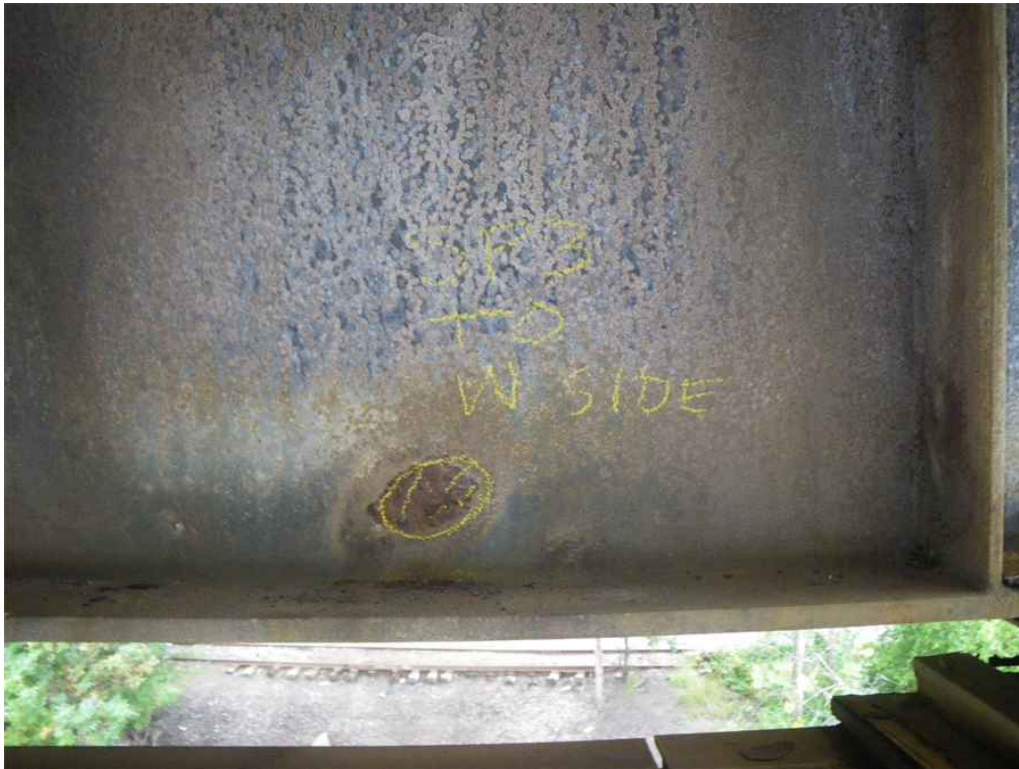
Photo 21: Span 3, Transom T0, Web, North Face, Looking South - Localized pitting section loss at area of failed galvanization.

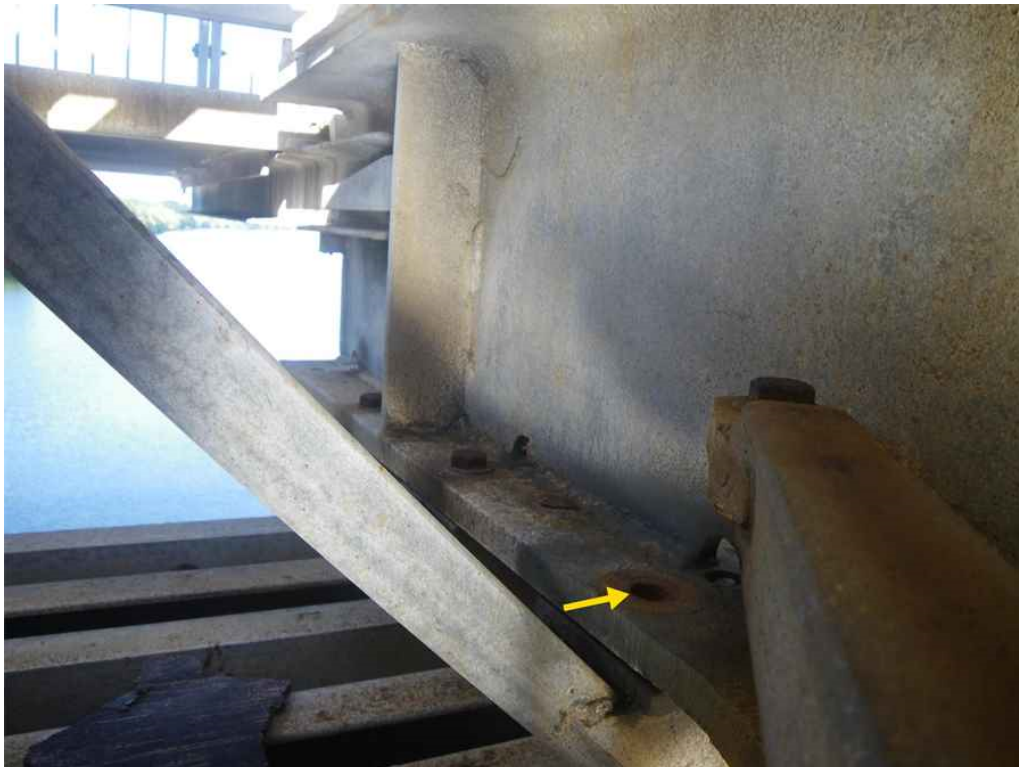
Photo 22: Span 3, Transom T16 at West Truss Bearing Area, Looking West - One bolt missing in southeast corner of transom bearing area. Note galvanization loss and surface rust on bolts.

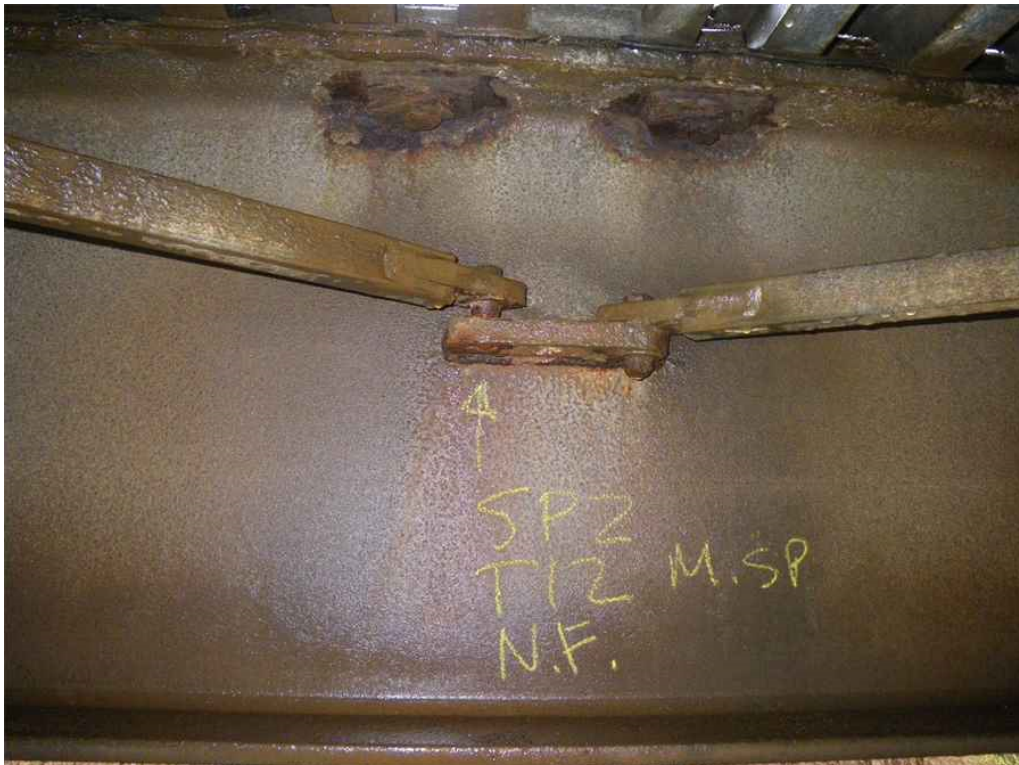
Photo 26: Span 2, Floor System Brace Between T12-T13, Connection at T12 for Middle East Brace, North Face, Looking South - Loose/disengaged bolt at bracing member connection.

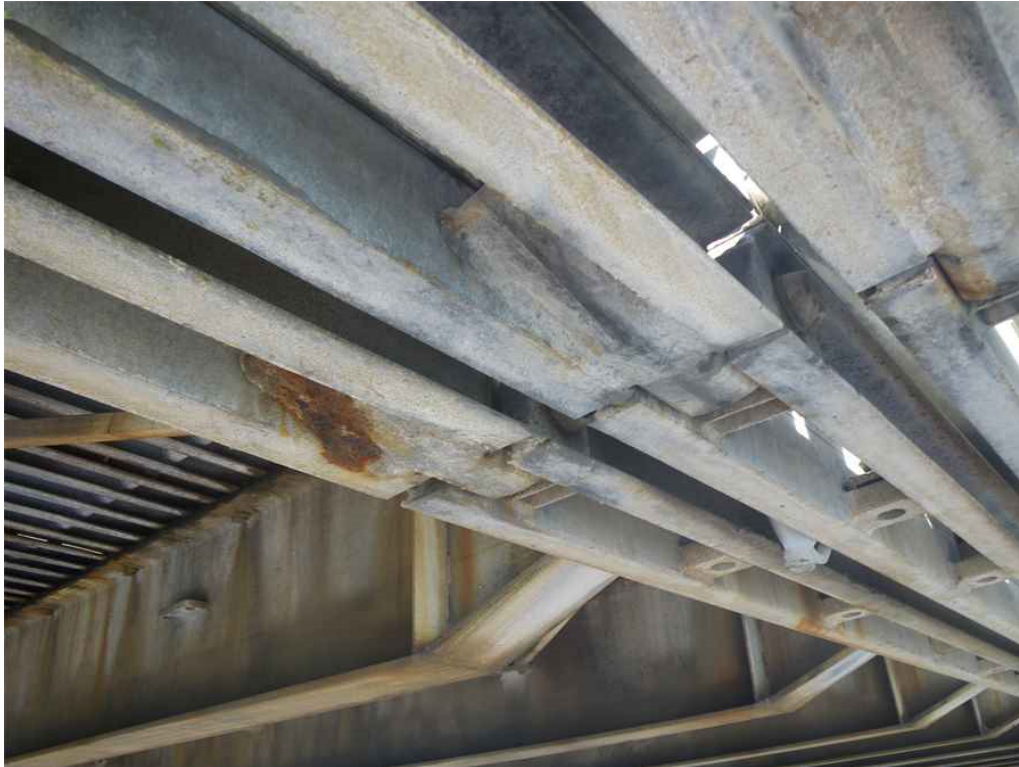
Photo 29: Span 4, East Truss, Lower Chord, Pin Between T17-T18, Underside, Looking Northwest - Loss of galvanization and surface rust.

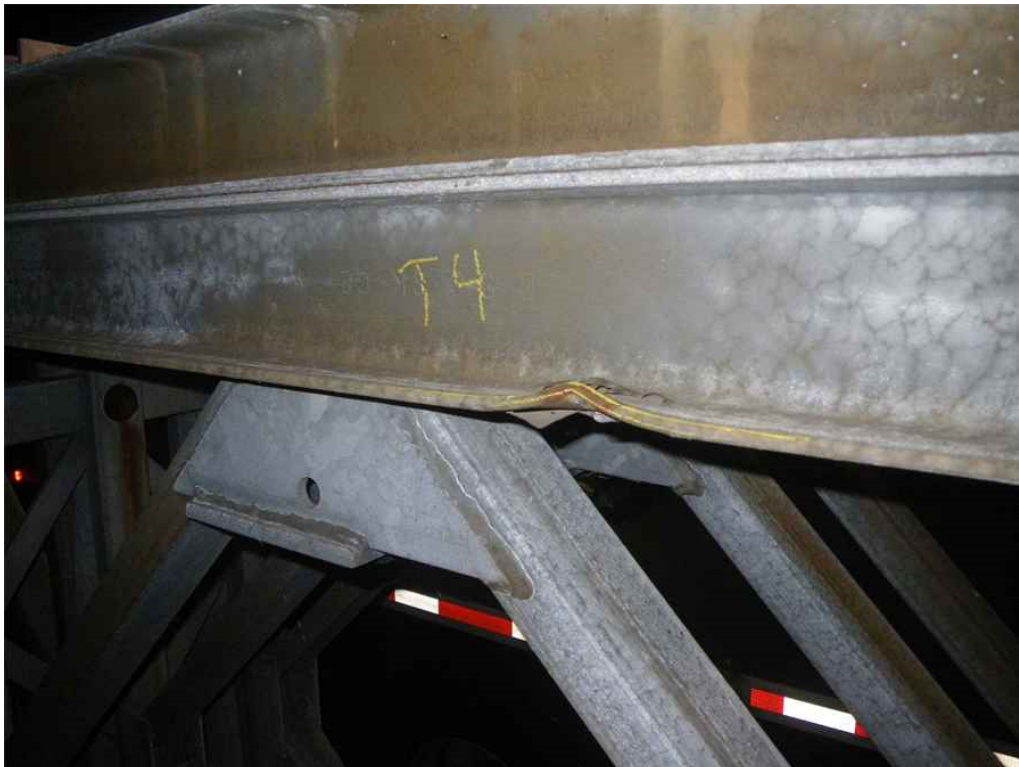
Photo 30: Span 2, East Truss, Upper Chord, East Bottom Channel located North of Pin Between T3-T4, East Face, Looking Southwest - East bottom flange bent upward.

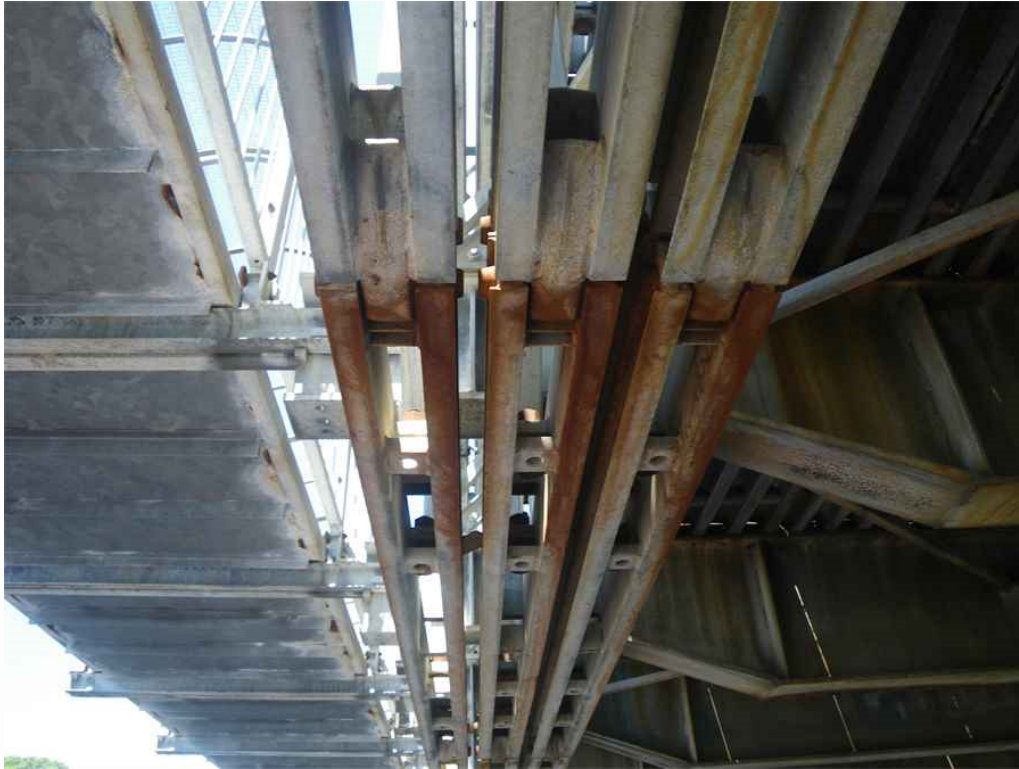
Photo 31: Span 7, West Truss, Lower Chord, All Lower Pins Between T5-T6, Underside, Looking North - All lower pins loose with abrasion dust.

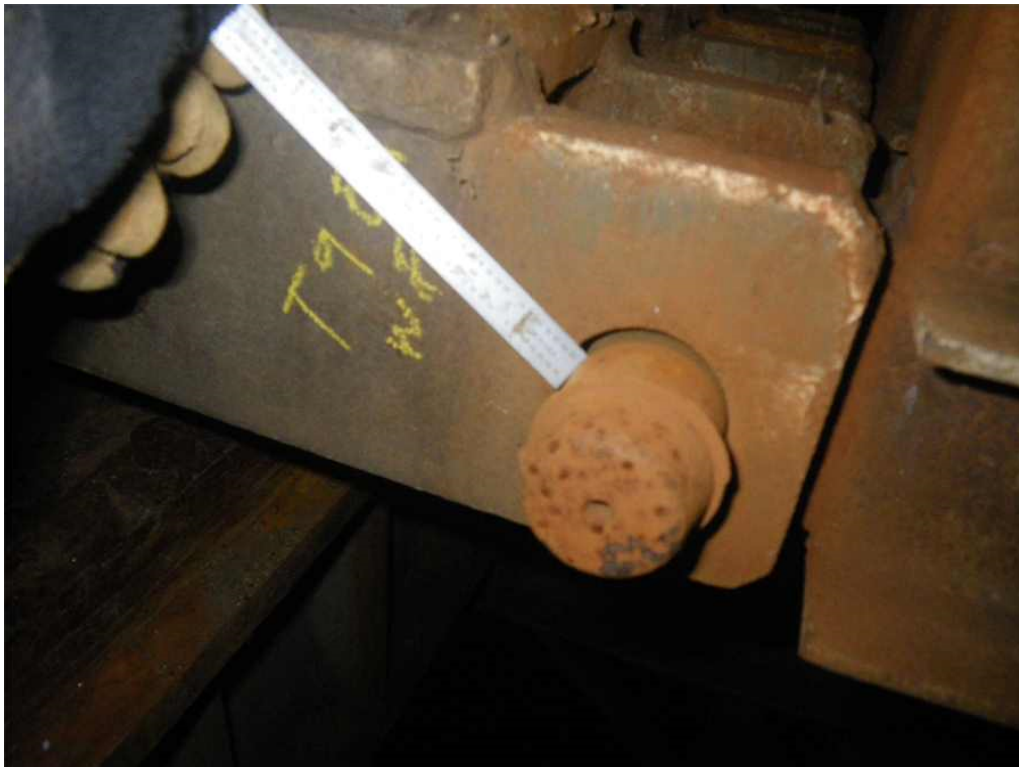
Photo 32: Span 1, East Truss, Lower Chord, West Lower Pin Between T9-Bearing, West Face, Looking Northeast - Loose pin with abrasion dust and up to 1/4" gap.

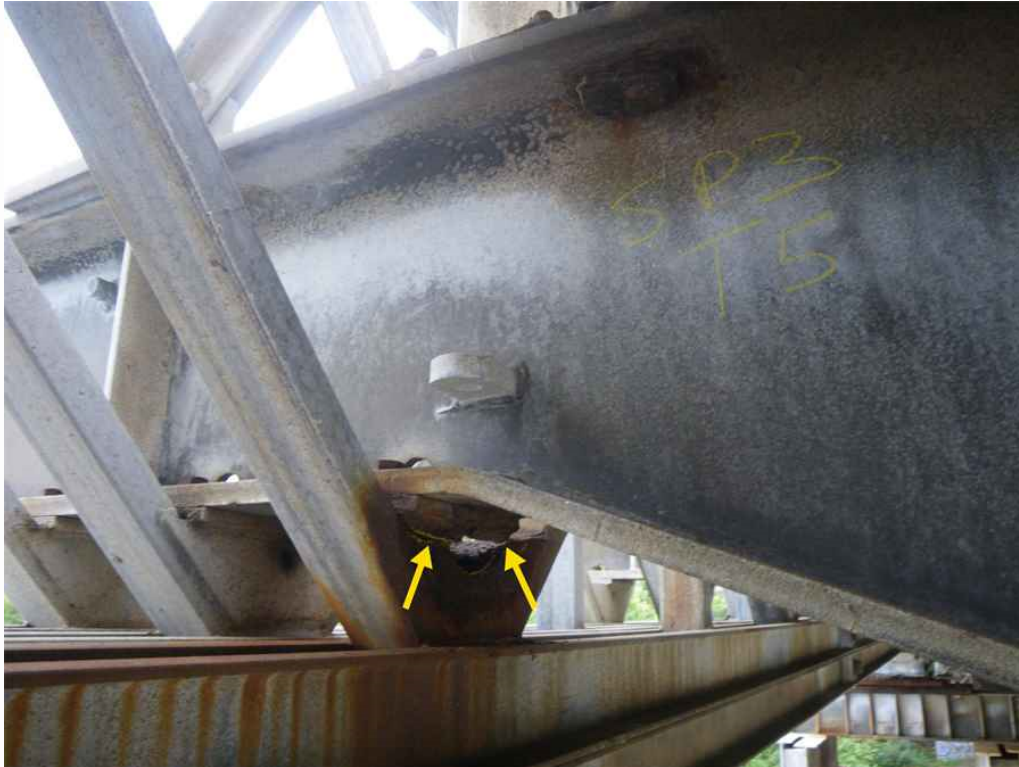
Photo 33: Span 3, East Truss, Lower Chord, Transom T5 West Panel Point Connection Plate, W Face, Lkg SE - Hole w/ adj full length crack of conn PL resulting in full separation on both sides of panel point.

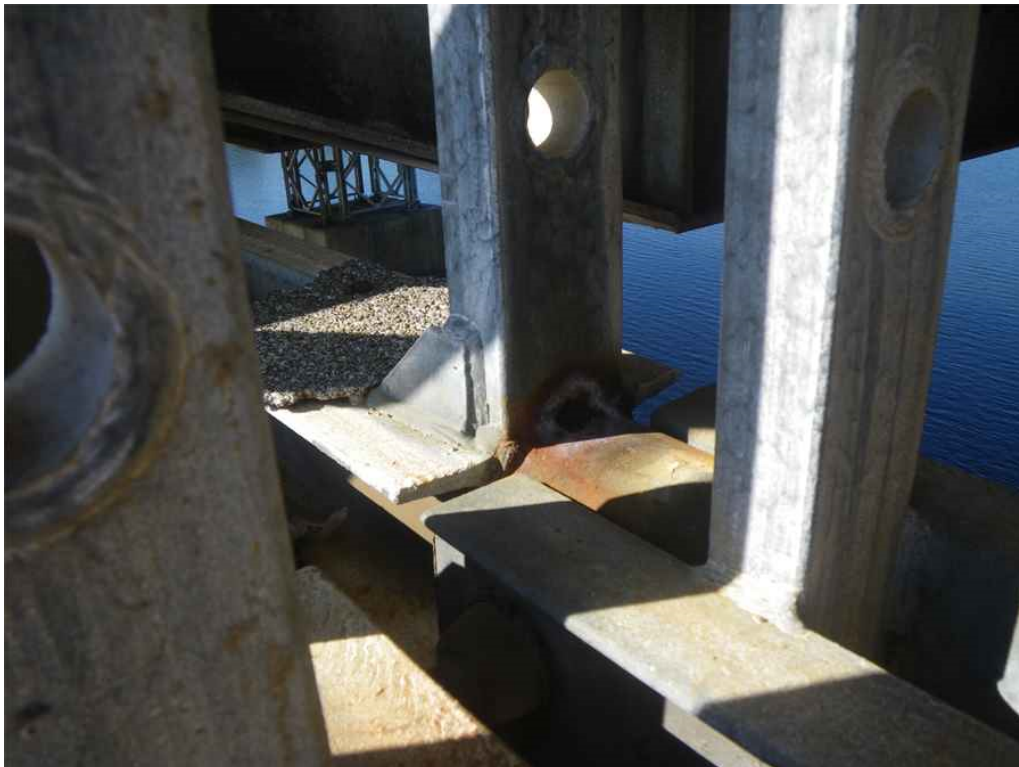
Photo 34: Span 6, East Truss, South of Pin Between T9-T10, West Vertical Member At Lower Chord Connection, North Face, Looking Southwest - Active corrosion at bottom of vertical member.
