STRUCTURES INSPECTION FIELD REPORT

B.I.N.
2M4

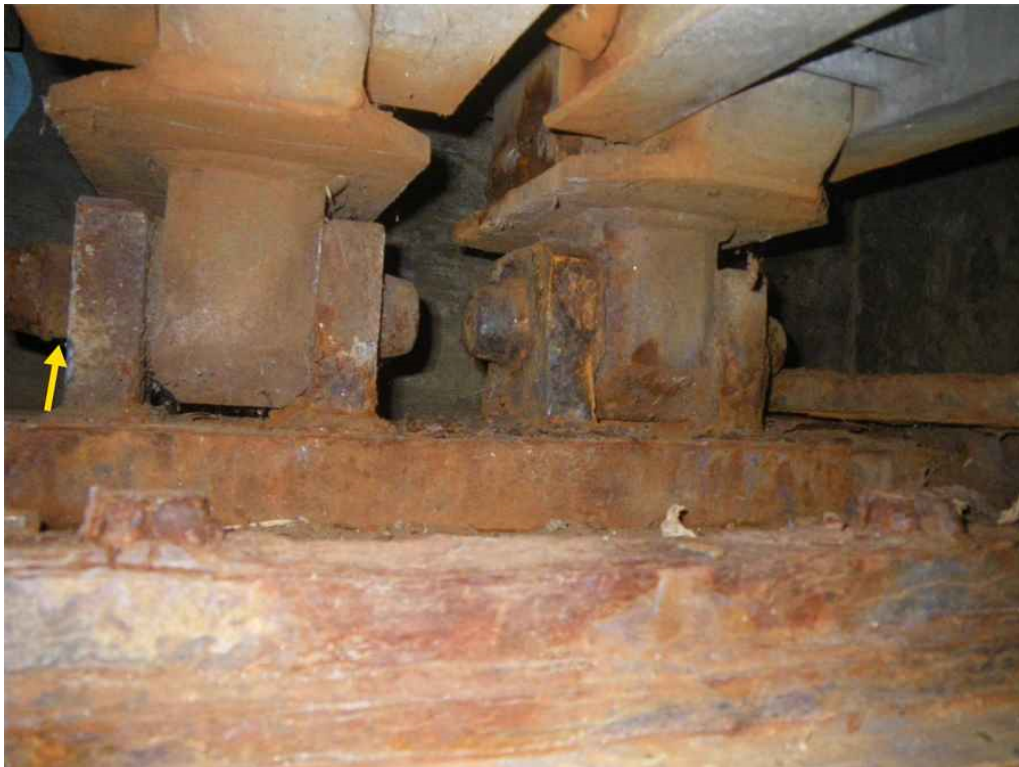
Photo 38: Span 1, East Truss, at South Abutment, West End Post, East Face, Looking Southwest - Pin and connection plate have heavy surface rust, and pin is missing retainer clip.

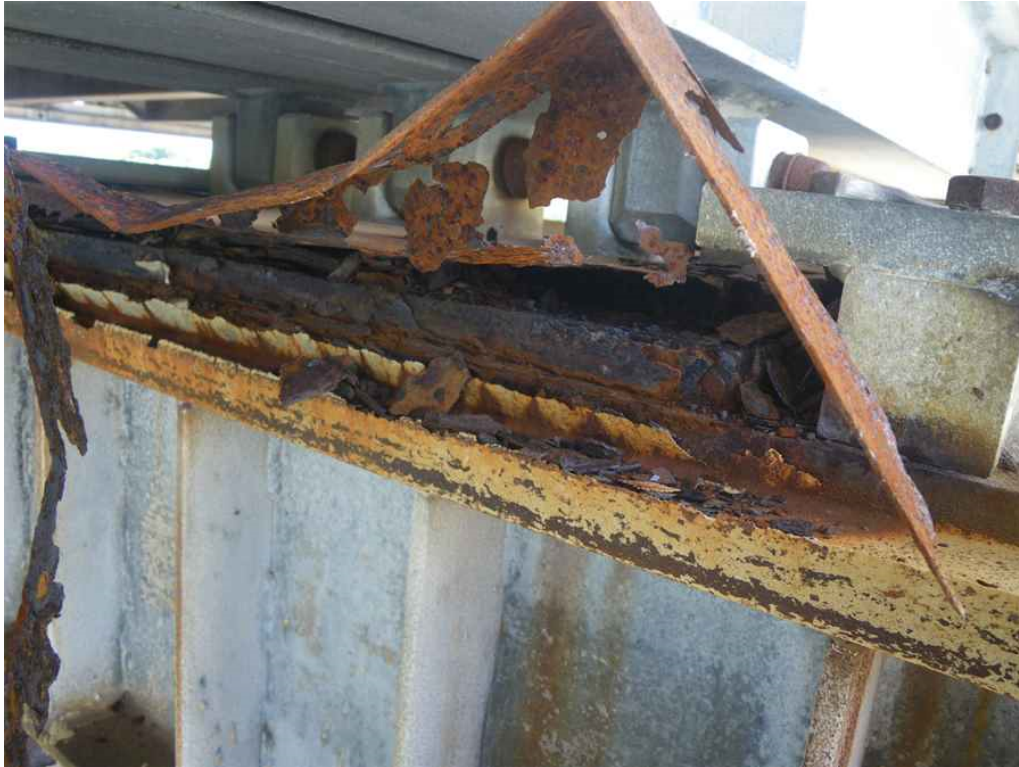
Photo 39: Pier 5, West Truss Bearing, Guide Plate, Looking Southeast - Failed galvanization with surface rust. Note sheet metal bearing cover section loss/holes and deterioration.

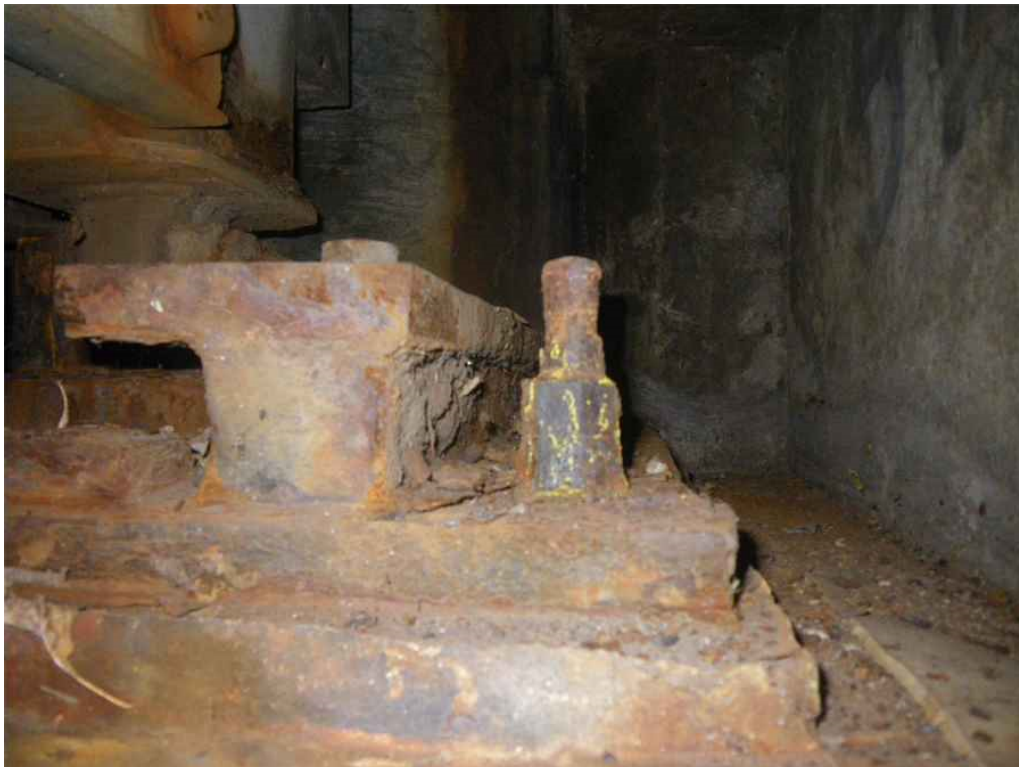
Photo 40: South Abutment, East Truss Bearing, West Anchor Bolts, Looking South - Section loss on northwest anchor bolt nut.

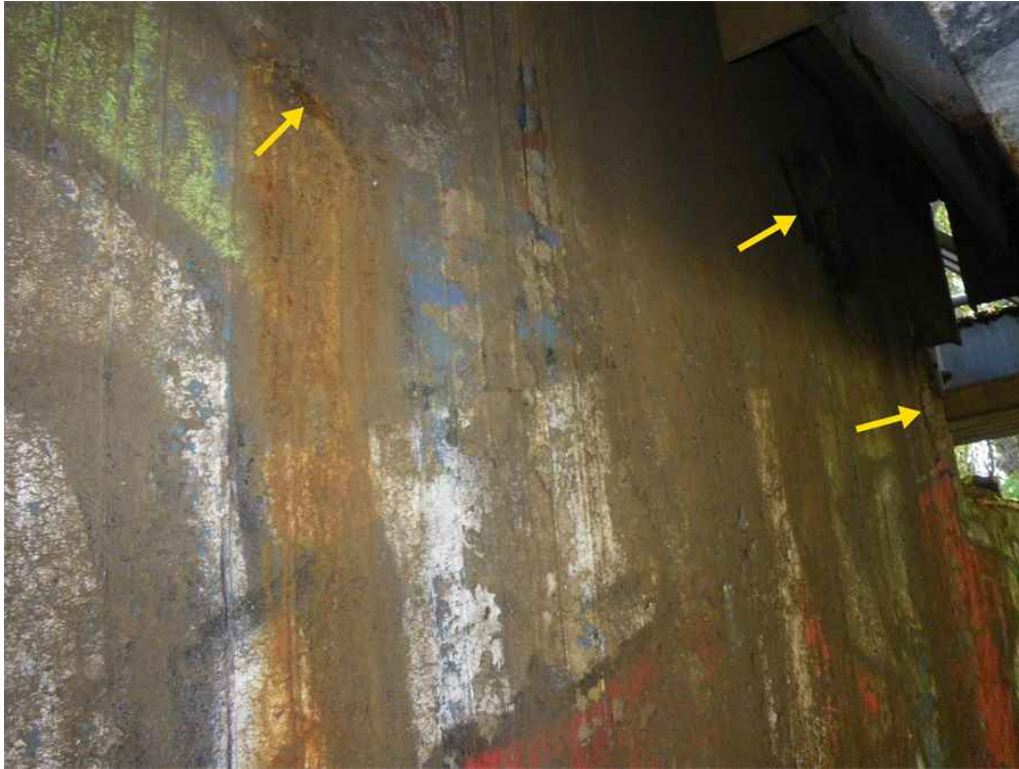
Photo 43: South Abutment, Breastwall, West Half, Looking Southwest - Three spalls with exposed rebar.

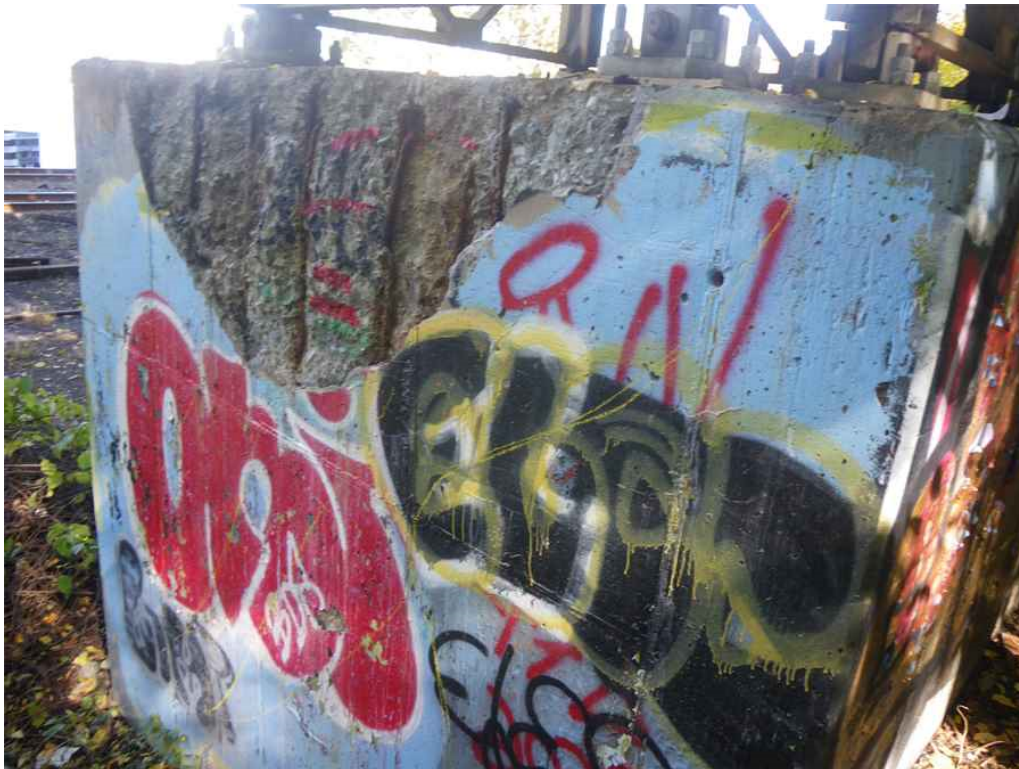
Photo 44: Pier 1, West Pedestal, West Face, Looking Northeast - Spall with exposed rebar with heavy surface rust and corrosion.

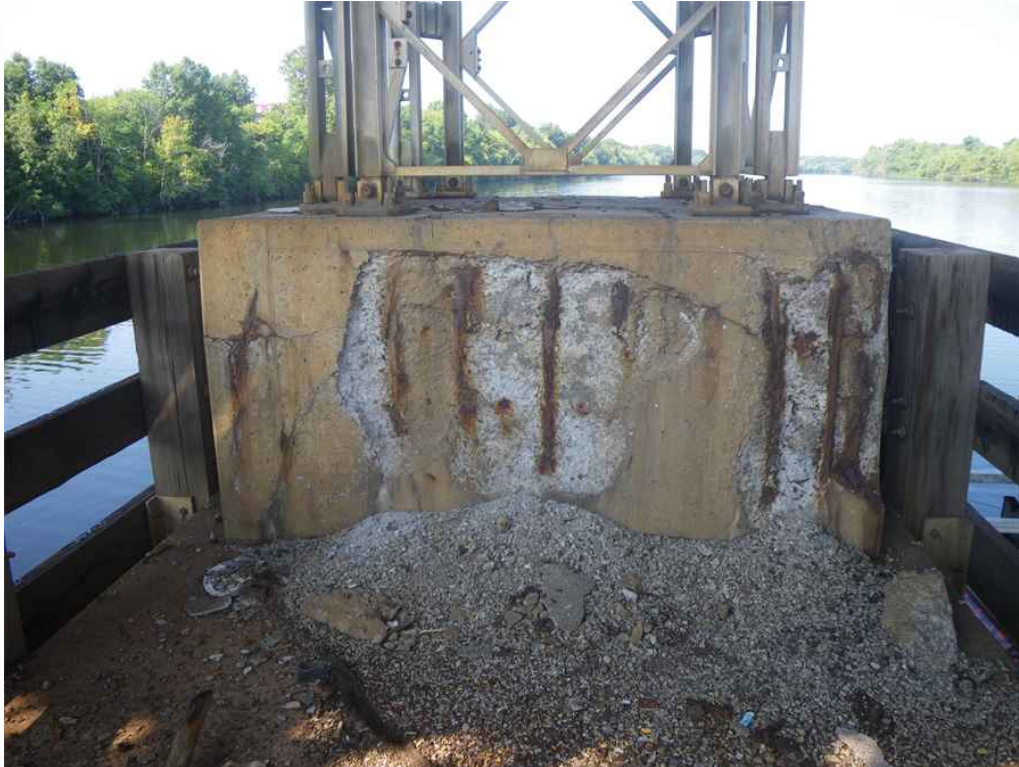
Photo 45: Pier 3, West Pedestal, East Face, Looking West - Spalls with exposed rebar with section loss.

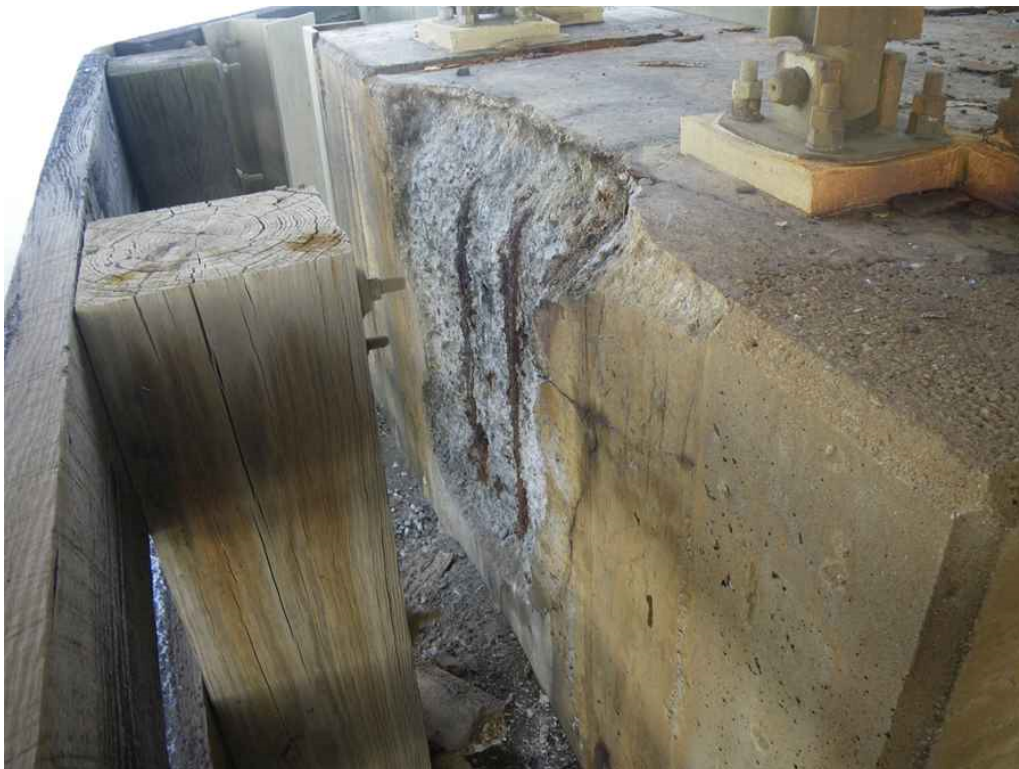
Photo 46: Pier 6, West Pedestal, South Face, Looking Northwest - Spall with exposed rebar and punky concrete.

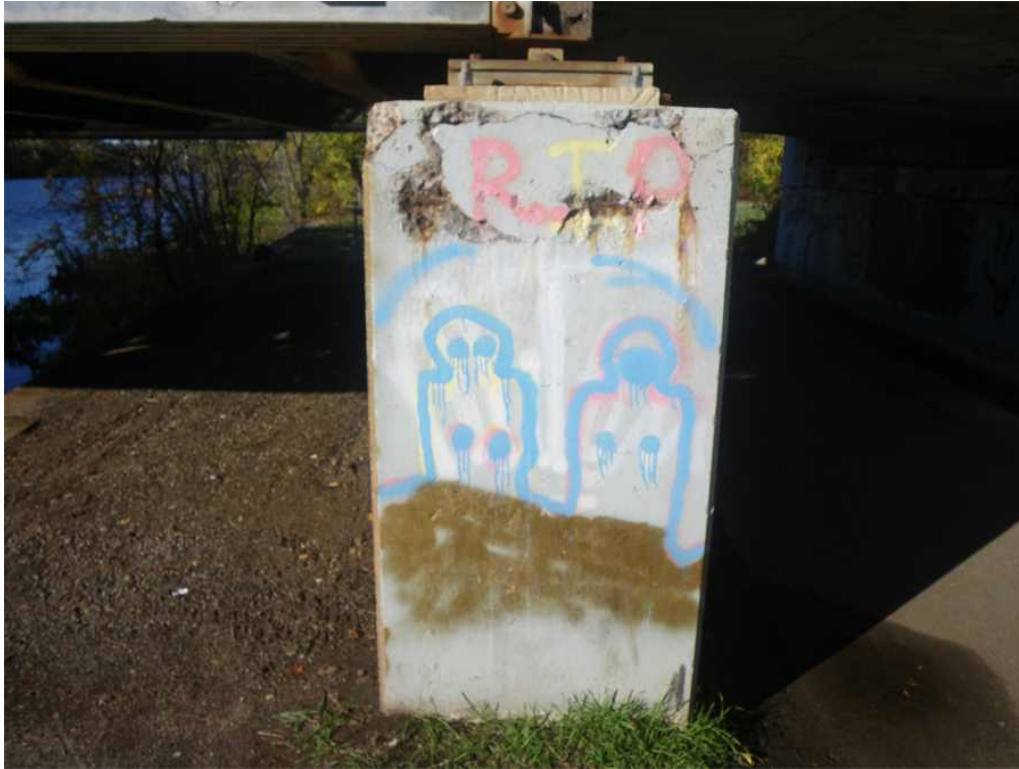
Photo 47: Pier 8, East Pedestal, East Face, Looking West - Full width spalled area with exposed rebar.

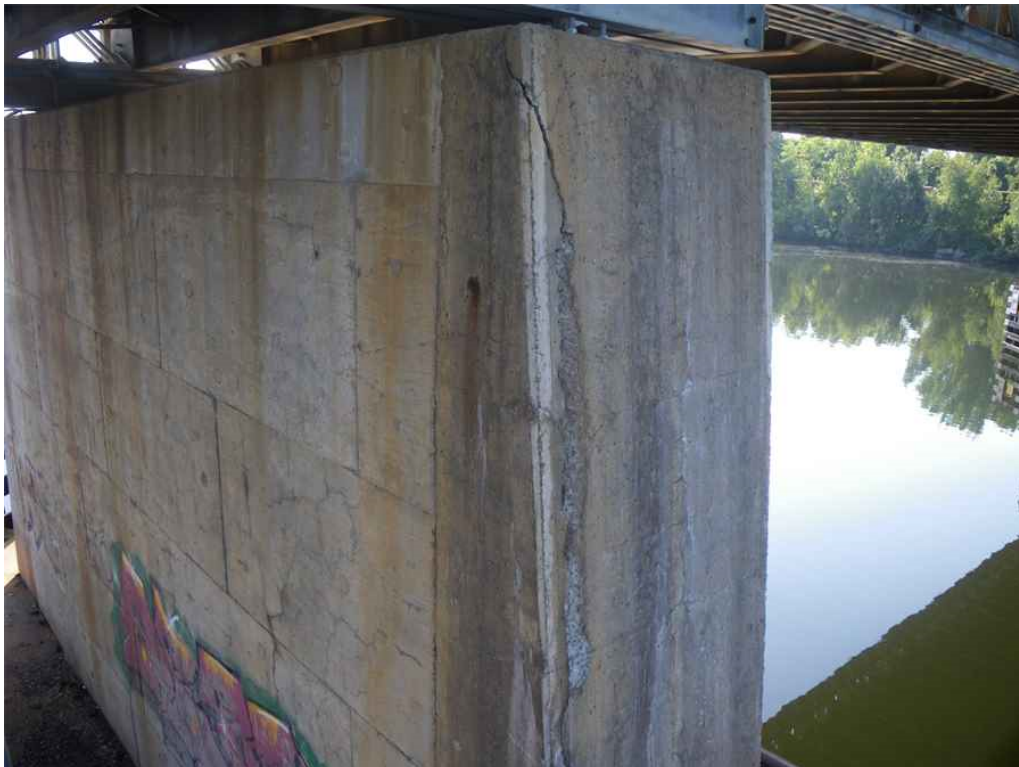
Photo 48: Pier 4, Pierwall, North and West Faces, Looking Southeast - Hairline map cracking with moisture on N face, and hairline map cracking with efflorescence and spall within hollow area at NW corner of W face.

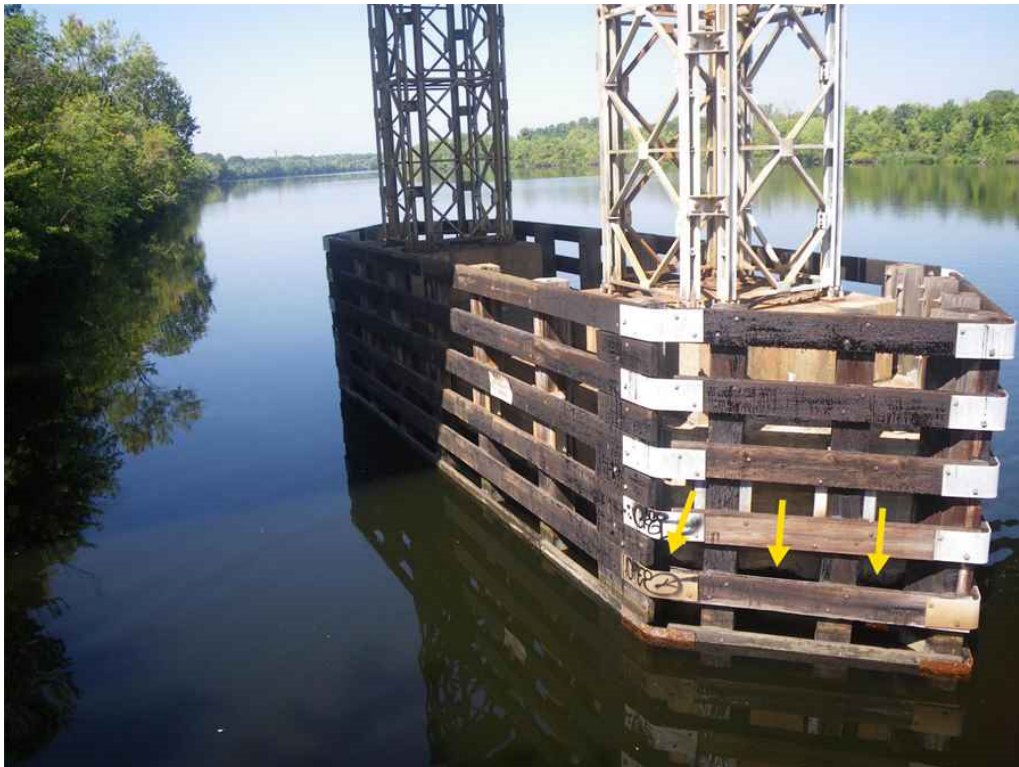
Photo 50: Pier 2, Pile Cap, South Elevation at East End, Looking Northwest - Spalls around base of pile cap.

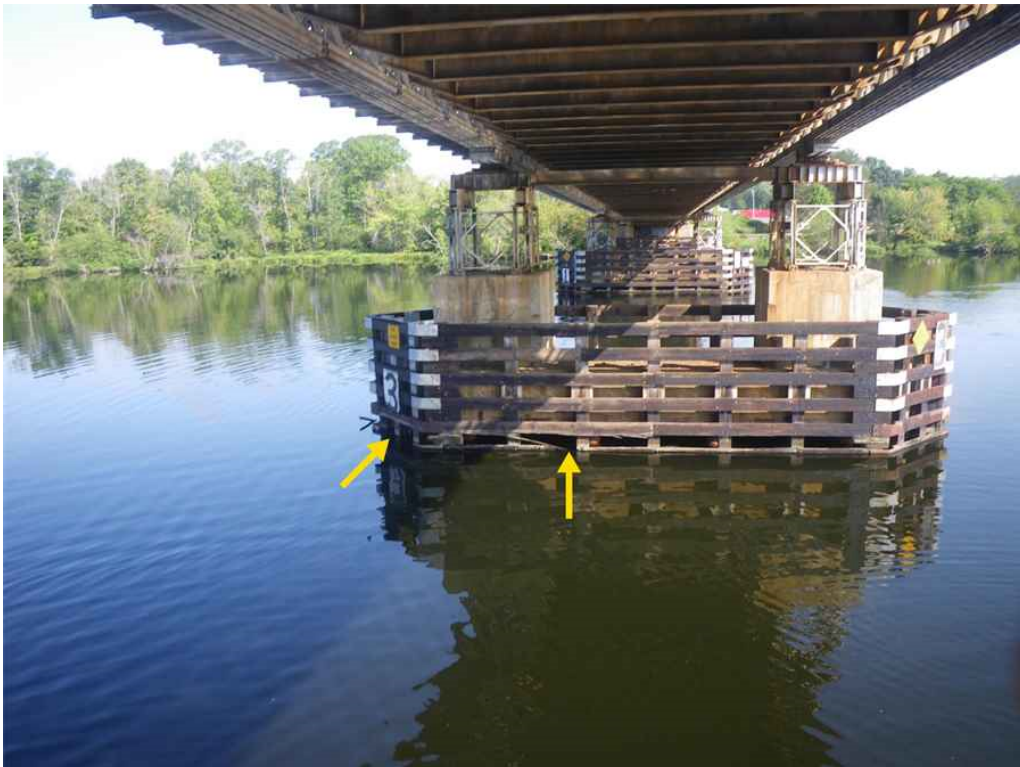
Photo 52: Pier 5, Timber Fender System, South Elevation, Looking North - Damaged waler 6th from top on west half of south face, and missing waler 6th from top at the west nose.

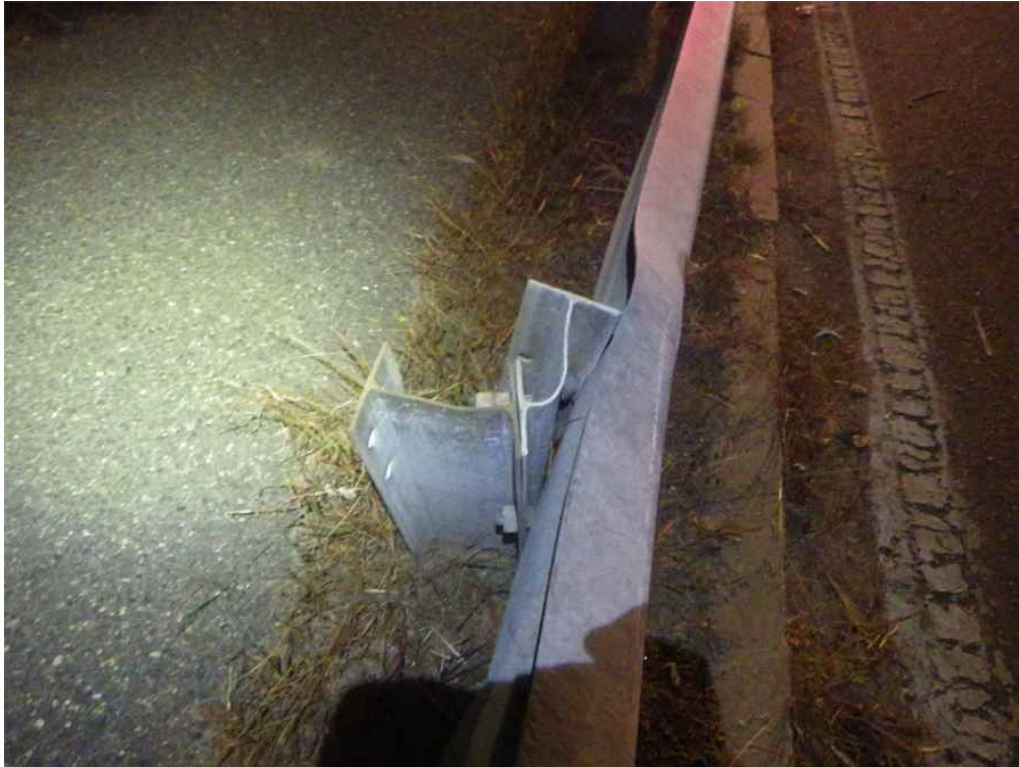
Photo 53: Northwest Approach Guardrail, Rail Post #11, Looking North - Collision damage to guardrail, and bent rail post.

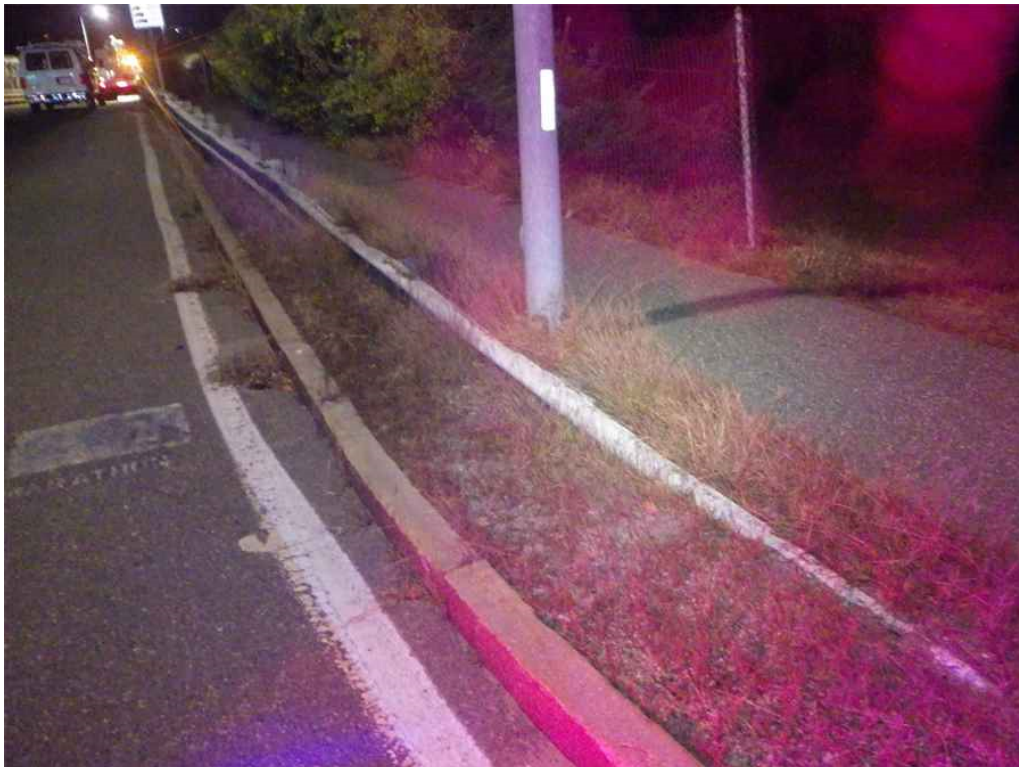
Photo 54: Northwest Approach Guardrail, Terminal End, Looking Southwest - Terminal end is buried and damaged.
