STRUCTURES INSPECTION FIELD REPORT

FRACTURE CRITICAL INSPECTION

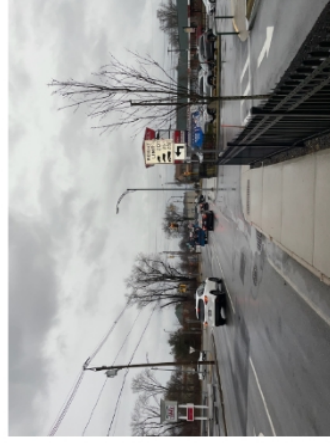
⑥ Advance weight posting sign that reads: "20, 25, and 28 tons."

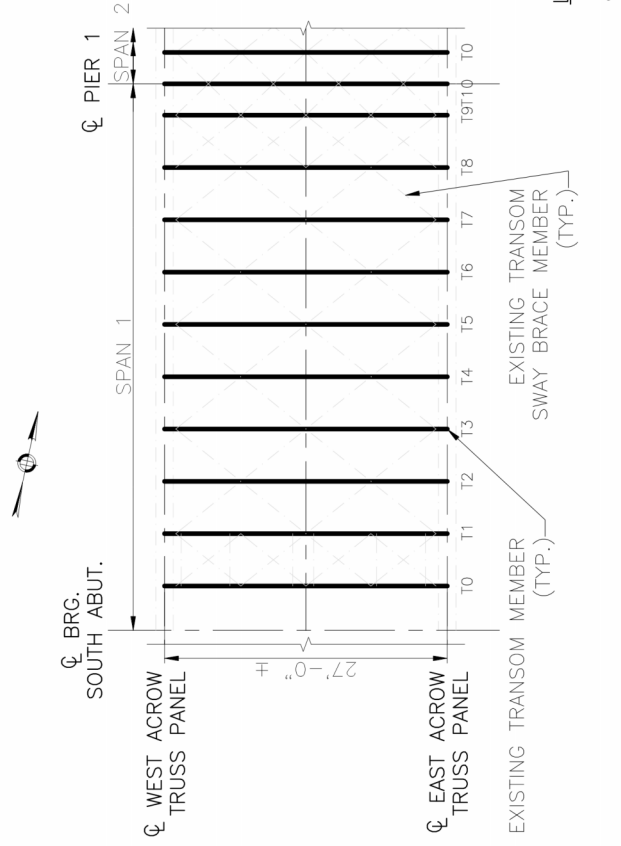
IDENTIFICATION OF FRACTURE CRITICAL MEMBERS (FCMs):
 FRAMING PLAN OF SPAN 1 ACROW SPAN, WITH TRANSOMS

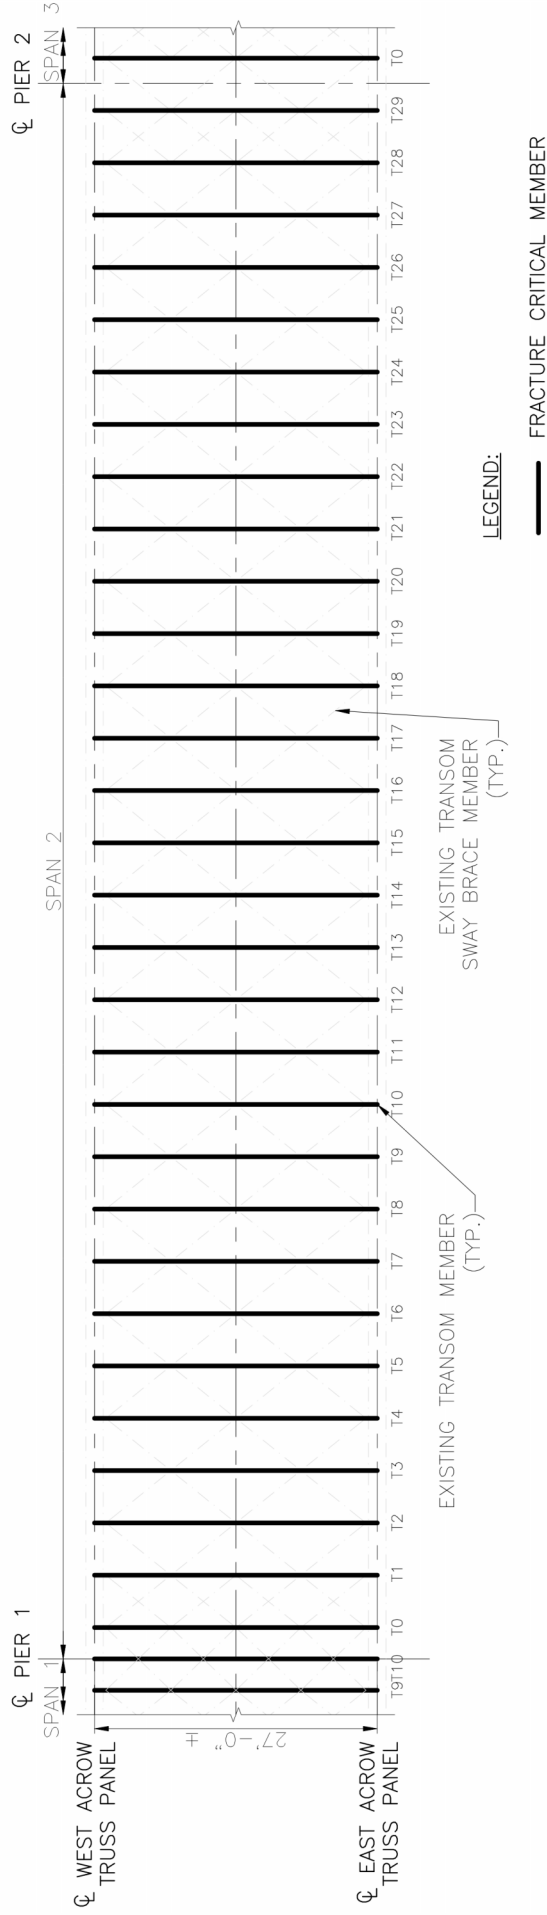
IDENTIFICATION OF FRACTURE CRITICAL MEMBERS (FCMs):
 FRAMING PLAN OF SPAN 2 ACROW SPAN, WITH TRANSOMS
 (SPAN 2 SHOWN, SPANS 3 THROUGH 8 SIMILAR)

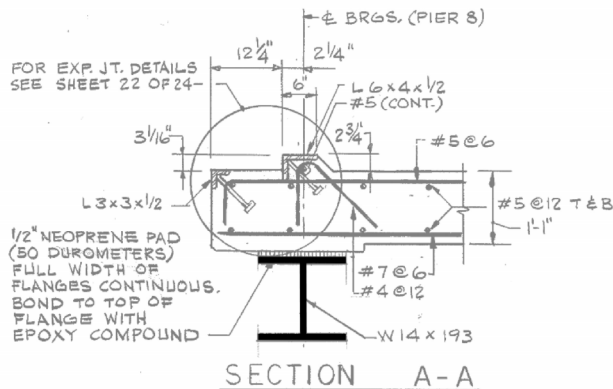
LEGEND:
 FRACTURE CRITICAL MEMBER

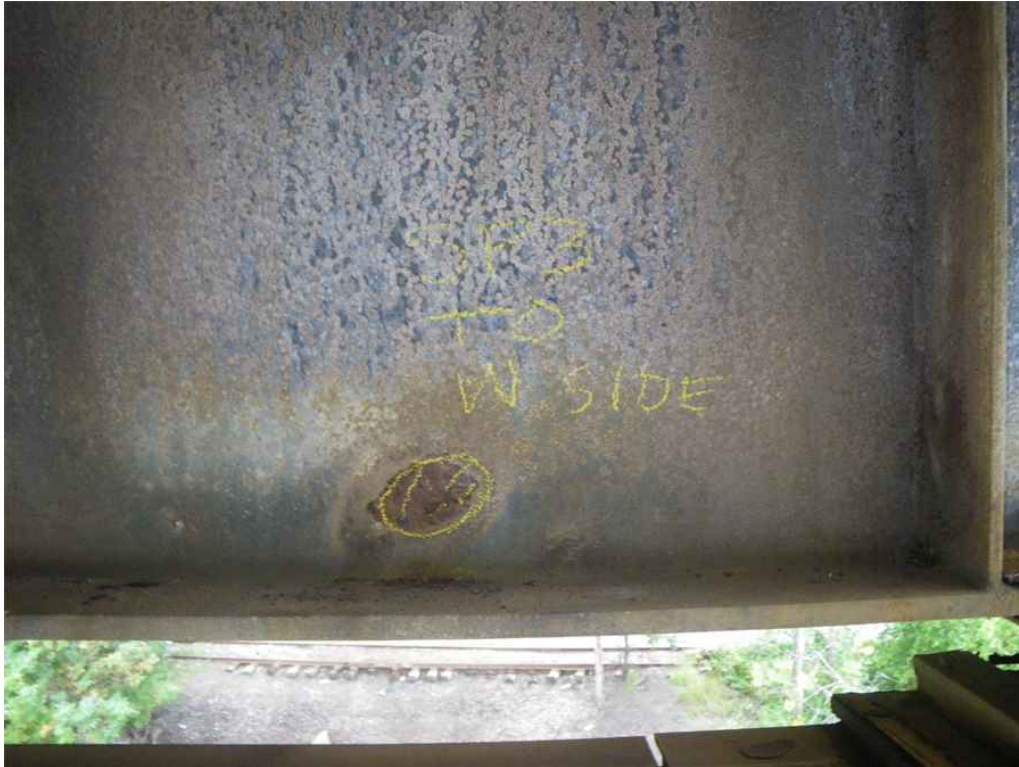
Photo 3: Span 3, Transom T0, Web, North Face, Looking South - Localized pitting section loss at area of failed galvanization.
